REPORT
on
STARBUCKVILLE DAM

SCHROON LAKE PARK DISTRICT

October 1971
RFA 1359

RIST-FROST, ASSOCIATES
Consulting Engineers
Glens Falls, New York

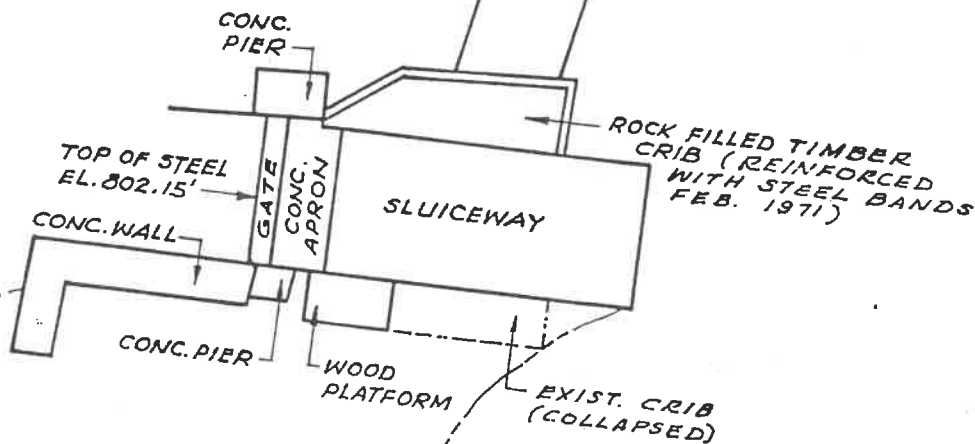
PLATE NO. 2

The dam is rockfill crib type construction. The main spillway is almost 140 feet long. A rockfilled crib structure separates the spillway from a sluiceway on the southwest bank. The flow through the sluice is controlled by a steel gate, 16 feet wide. The bed of the sluiceway is timber. Another rockfill crib and concrete retaining wall separate the sluiceway from the southwest earth embankment. On the northeast side, the spillway terminates at an embankment composed of sand, gravel and boulders. Apparently, the sluiceway referred to in earlier reports was washed out or destroyed; subsequently, fill was placed over the remains of the sluiceway.

The cribwork of the spillway is in good condition. The main members have not deteriorated appreciably. The rockfill has retained its strength. The planking on the upstream side is

generally in poor condition. Several small whirlpools are evident behind the spillway crust. When the spillway was uncovered, leakage underneath the crib was noticed. The planking should be replaced and backfilled with impervious material to prevent the leakage. The planking on the downstream side of the spillway crest is worn but still sound. The two timber cribs adjacent to the sluiceway are in poor condition. The members in the high sections are totally rotted caused by the continual wet-dry cycle. The lower portion of the crib is in somewhat better condition but should be replaced promptly. Probes were driven completely through some members, indicating little or no strength. The planking on the sluiceway is structurally sound. The gate structure is also sound. Some concrete has spalled from the piers; these areas should be patched. When steel bracing was installed to protect the cribwork, bolts holes were drilled through the concrete piers, at the time the concrete still had retained its strength.

OLD SLUICEWAY
BURIED UNDER
ROCK FILL.

The existing sluiceway and cribs should be replaced with a concrete structure. The concrete will not be deteriorated by the wet-dry cycle as the wooden structure has. The concrete sluiceway should utilize the existing gate structure and be incorporated into the existing spillway.

Replace the planking on the upstream and downstream faces of the existing spillway. At the same time, impervious backfill should be placed on the upstream planking to reduce seepage beneath the structure.
