DESIGN REPORT
for the
RECONSTRUCTION of the STARBUCKVILLE DAM

Schroon Lake Park District
Essex and Warren Counties, New York

December, 1998

Christie Engineering
8 East Main Street
Malone, New York

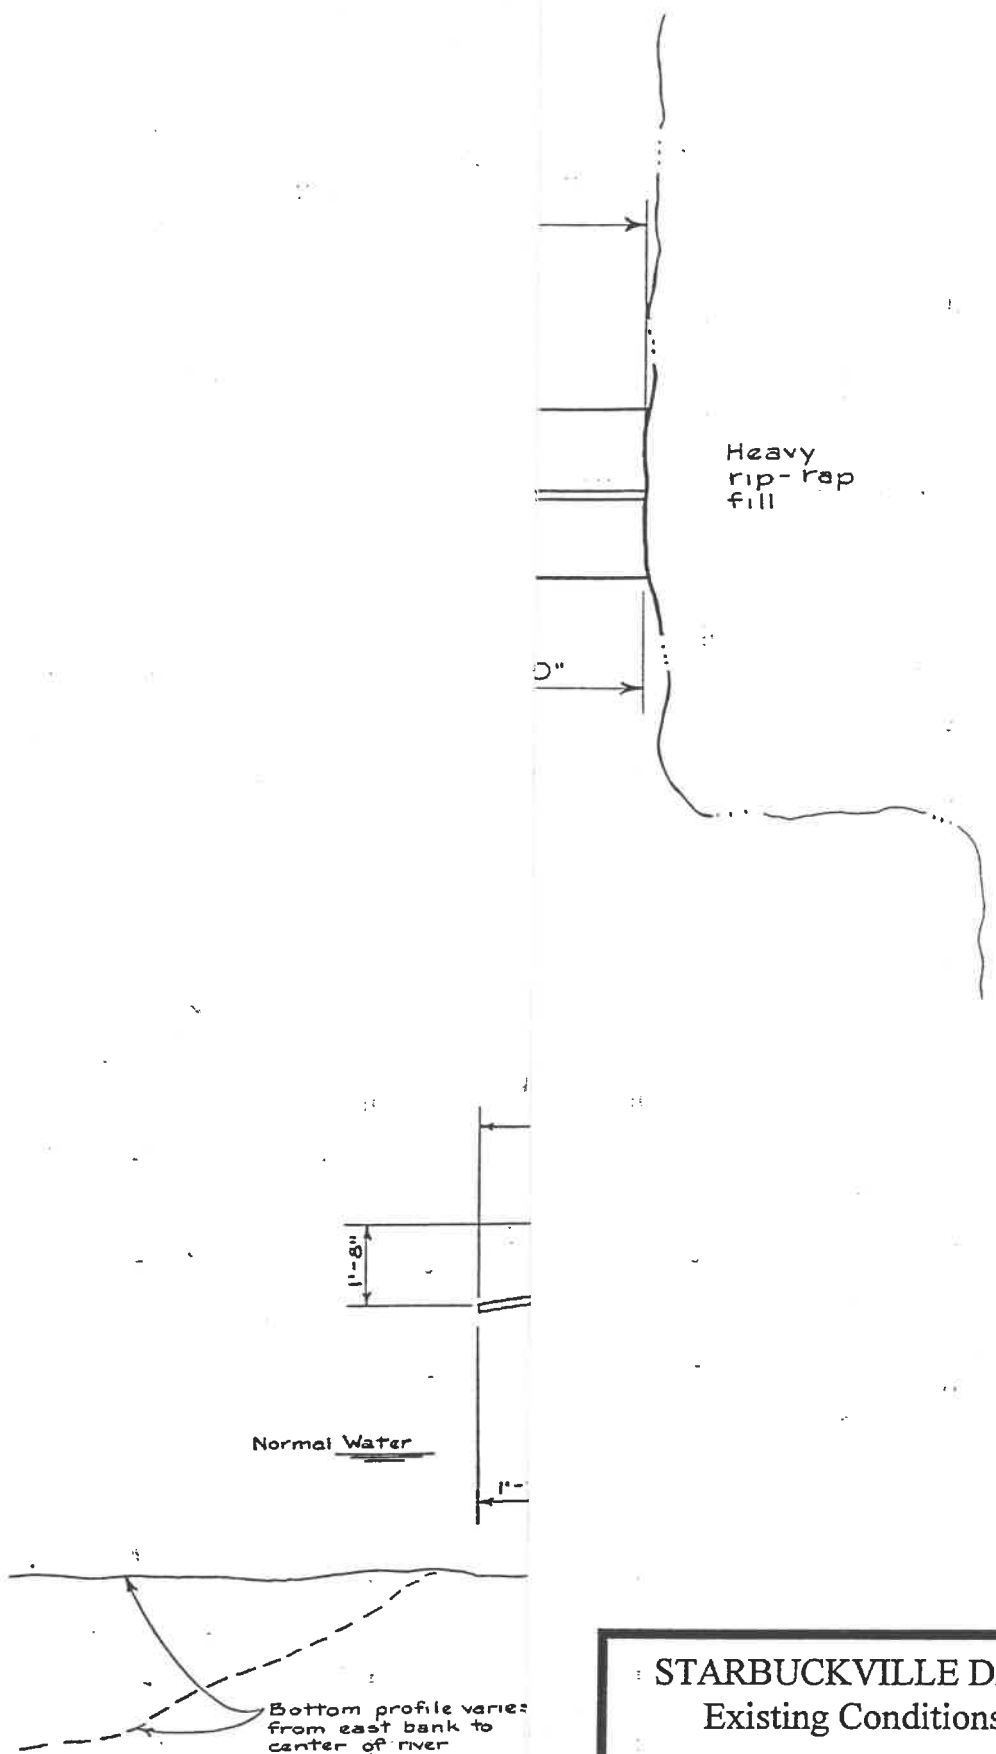
Figure 2

On October 7, 1998 we conducted an inspection of the Starbuckville Dam. The water surface was approximately 1-foot below the top of the timber crib spillway and the upstream planking had approximately 4-feet of exposed wood surface. Most of the planking upstream of the crest beam was covered with silt. The entire downstream slope of the timber crib was exposed. The tailwater was 3-feet below the downstream edge of the timber planking on top of the spillway. Figure No. 2 shows the existing configuration of the dam as found on our inspection.

Our inspection indicated that the overall condition of the logs in the crib structure were in fairly good condition. There were some small pockets of rot detected in the western most area of deck removal, but nothing of any significance. The area of weakness that was discovered during this inspection was at the ends of many of the timber logs that make up the crib. Rot had penetrated into approximately a quarter of the ends that we could see, thus weakening the end and allowing the weight of logs, decking and rocks to compress and crush the ends of the timbers and thus sag the crib itself. This condition will very likely continue to spread and allow more settlement and sagging.

In both of the inspection areas where decking was removed it was obvious that some of the smaller rocks in the cribbing had been washed out, which allowed the overall rock fill to settle. This settlement has left a void between the top of the rock fill and the underside of the timber decking of 12 to 32 inches. This separation appears to extend over the full length of the spillway.

There was only one significant leak noted in the timber crib spillway and that was near the eastern inspection point. It appeared to be primarily due to wide cracks in the upstream planking between two or three adjacent planks that were not covered with soil or filled in with silt. This type of leak is not unusual for timber crib dams and could be corrected easily with board overlays.

The sluiceway and sluiceway appear to be constructed on top of a timber crib foundation. The structure is in good condition with only a couple of areas that should receive attention. The first area is the toe of the sluiceway structure that has suffered some erosion under the end of the concrete slab and around the supporting timber crib. The second area is a separation in one of the construction joints where the westerly retaining wall abuts the concrete gate support structure. Both of these areas can be repaired with concrete.

The east embankment is protected with heavy riprap over earth fill and shows no signs of seepage or leakage. The west embankment has riprap on the upstream face and does have a significant leak exiting approximately 1/3 of the way up the downstream embankment face and approximately 40-feet from the sluiceway.

Because of the deterioration that is beginning to take place in the timber crib, and the extreme deficiency in flood capacity, (see Hydrology and Hydraulics), we are proposing to remove the existing dam and construct a new concrete gravity overflow/drop spillway with a new 12-foot east side sluiceway. The spillway crest elevation will remain the same and the existing sluiceway/sluiceway will remain in place.

The existing sluiceway and gate will remain in place and have the downstream end of the apron slab encased in a concrete wall to stop further erosion. We will also change the drive for the hoisting mechanism at the existing gate to facilitate a faster operation.

Both embankments will be raised approximately 1-foot so that we have the top of the embankment at 7-feet above the crest of the dam on both sides of the river. At the same time a grouting program will be undertaken to seal off the leak that exists in the west side embankment.
