NORTH CREEK TRAIN STATION COMPLEX

STRUCTURAL INVESTIGATION

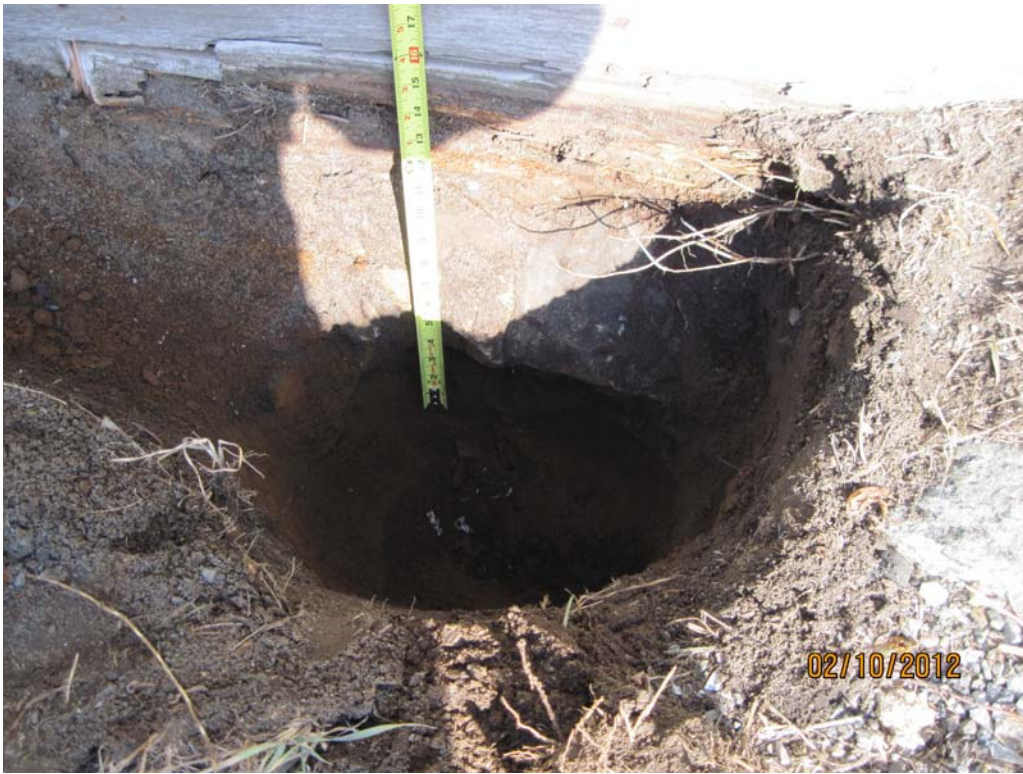
Photograph 7 – Stables Stone Foundation

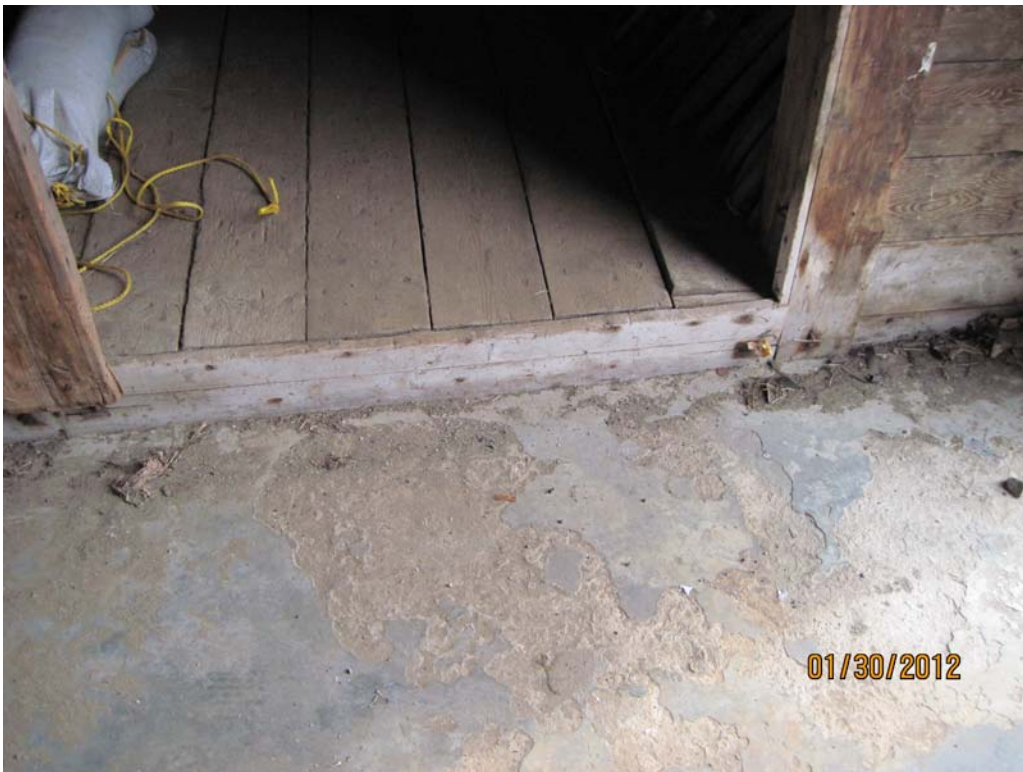
Photograph 8 – Stables Transition of Wood Floor to Concrete Slab

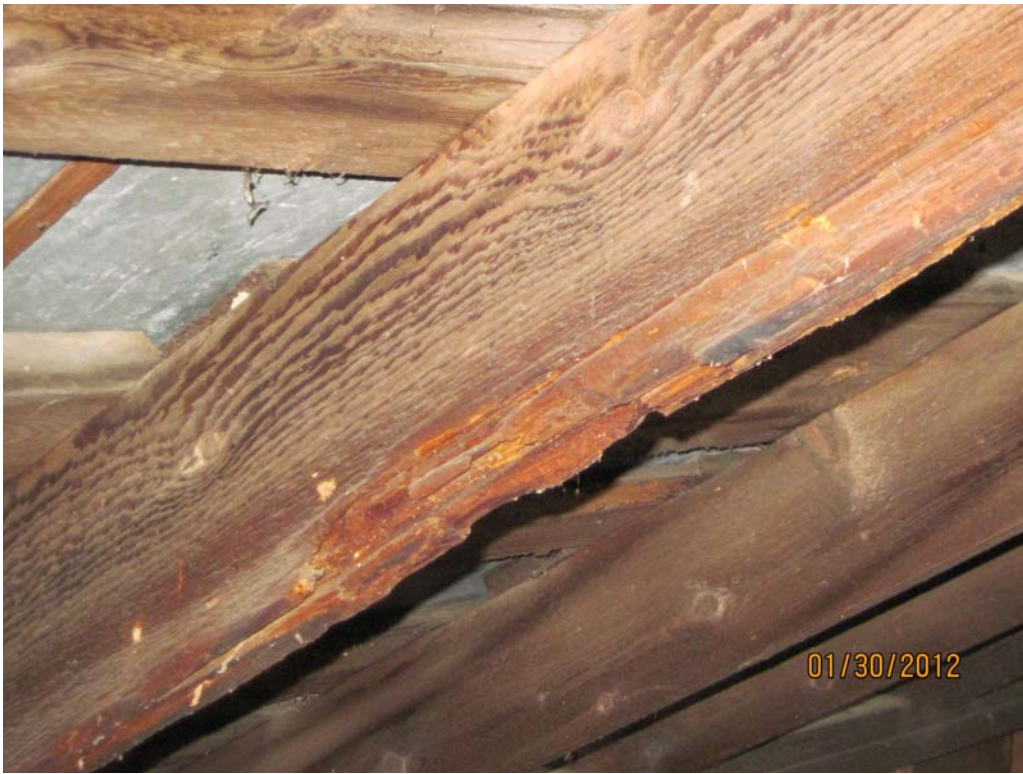
Photograph 9 – Stables Decayed Portion of Roof Rafter

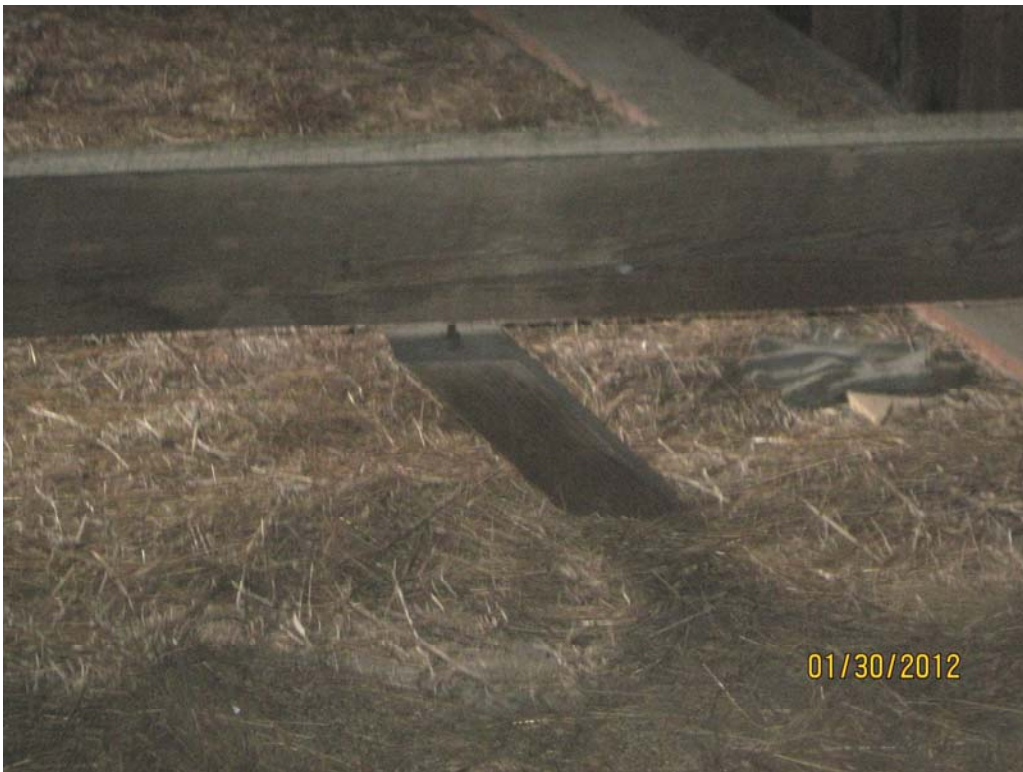
Photograph 10 – Stables Knee Brace Has Pulled Away From Tie Beam

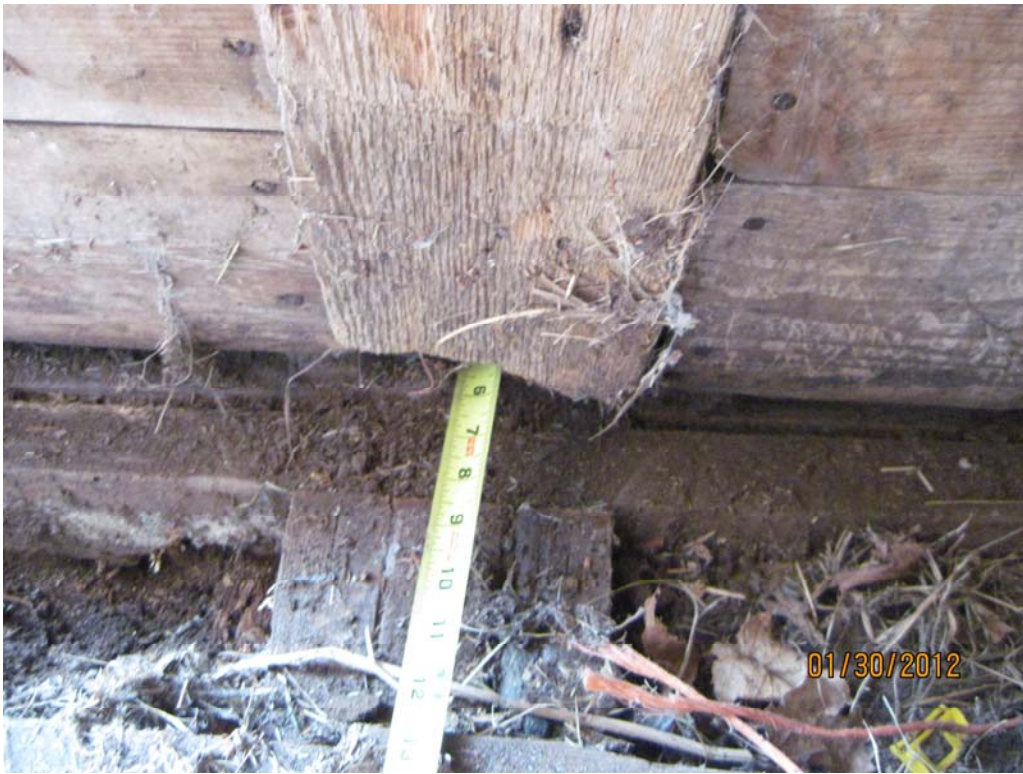
Photograph 11 – Stables Decayed Post Base

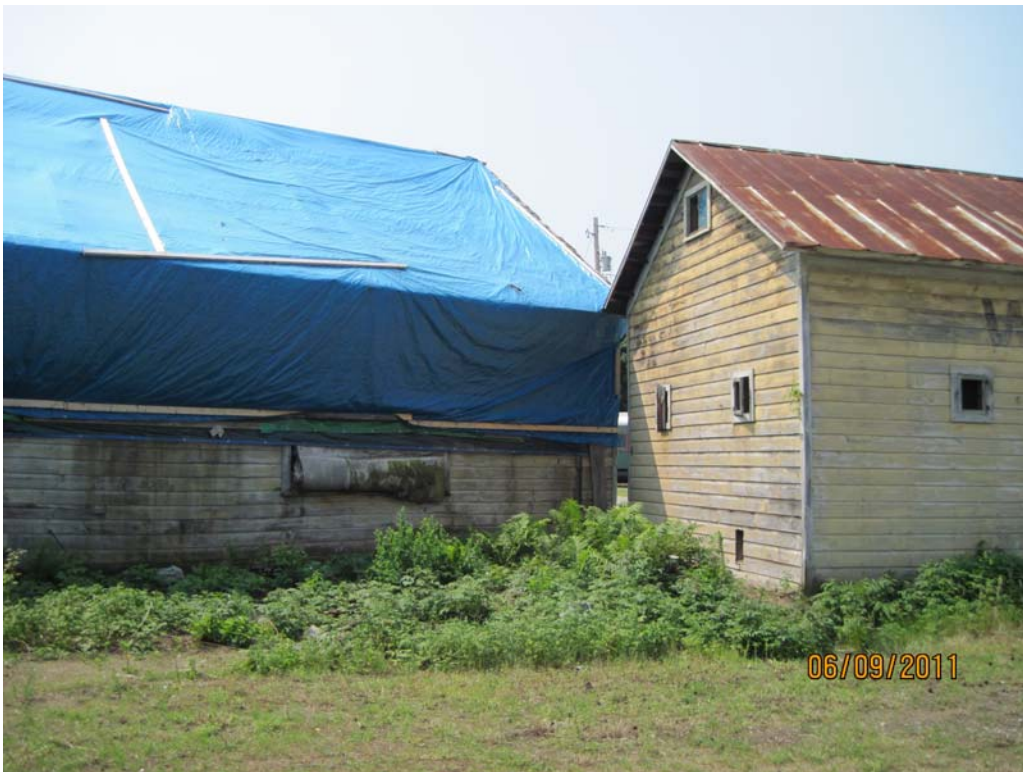
Photograph 12 – Scales Building North Side with Roof Collapse, Note Sag in Siding on Left Side of Picture.

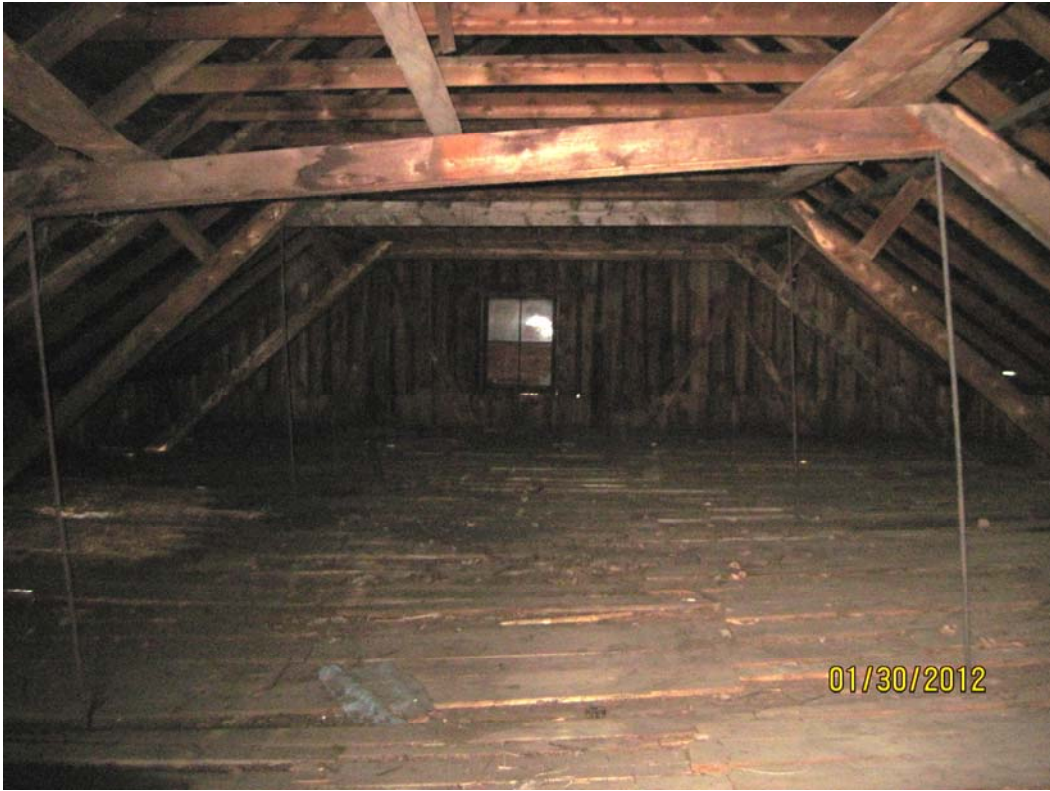
Photograph 15 – Scales Bldg. Truss Framing, Failed Truss on Left

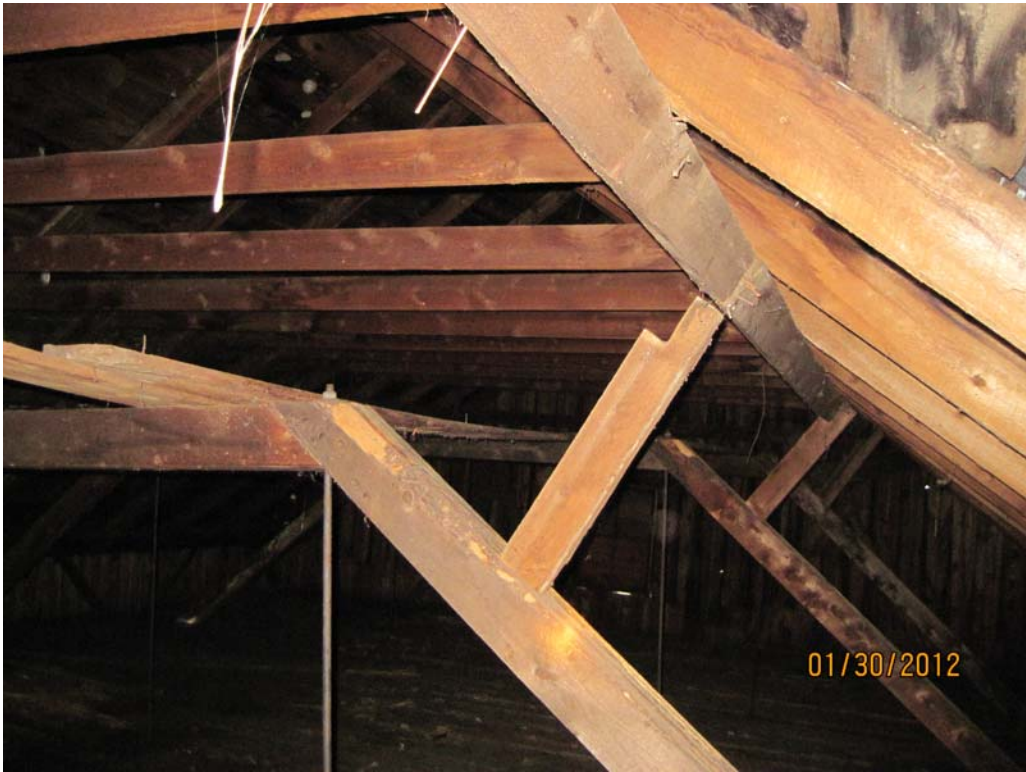
Photograph 16 – Scales Bldg. - Purlin Support of Rafter Pulled Away From Truss

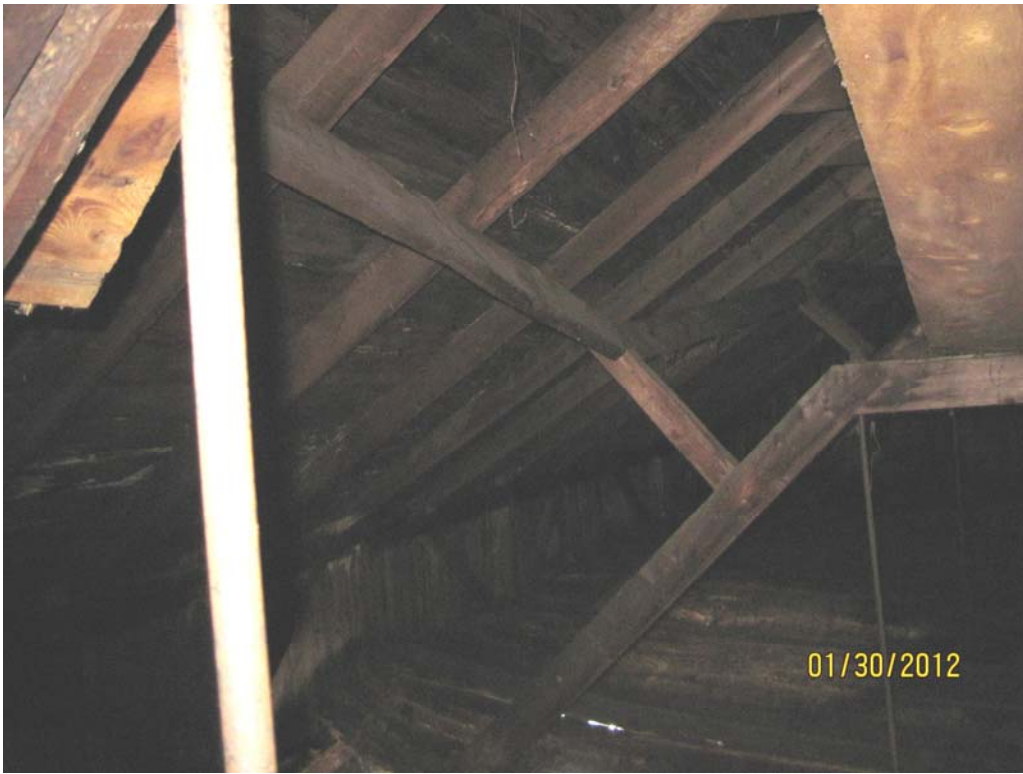
Photograph 17 – Scales Bldg. – Failed Bearing End of Truss

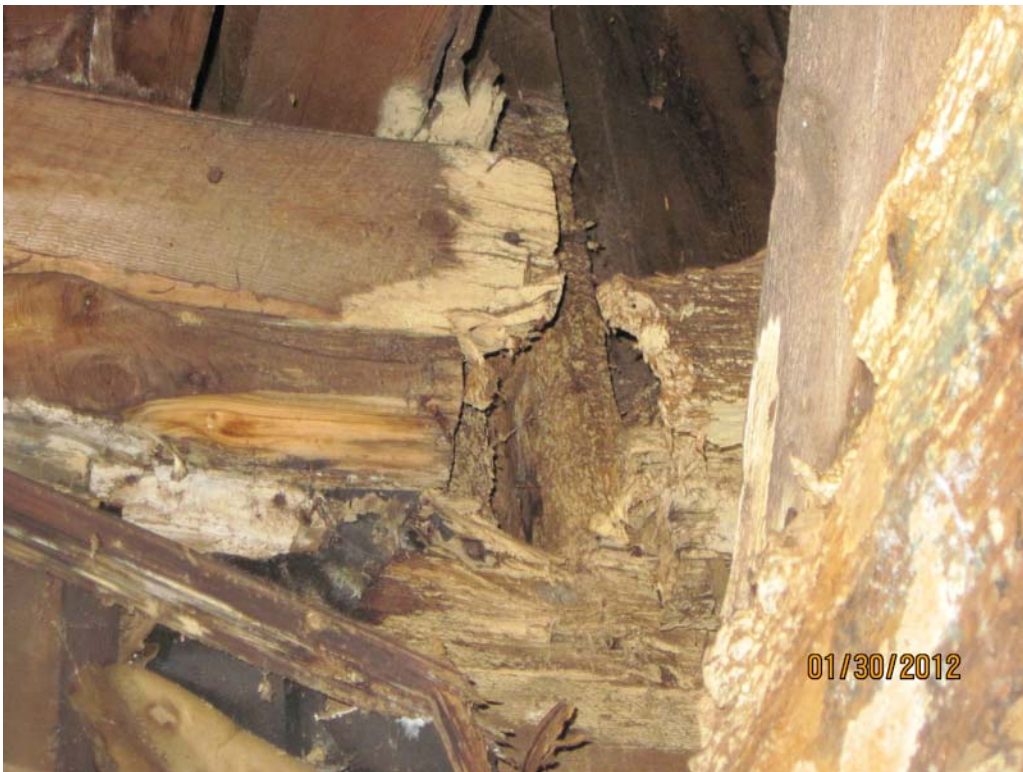
Photograph 18 – Scales Bldg. – Rotten Truss to Column Connection

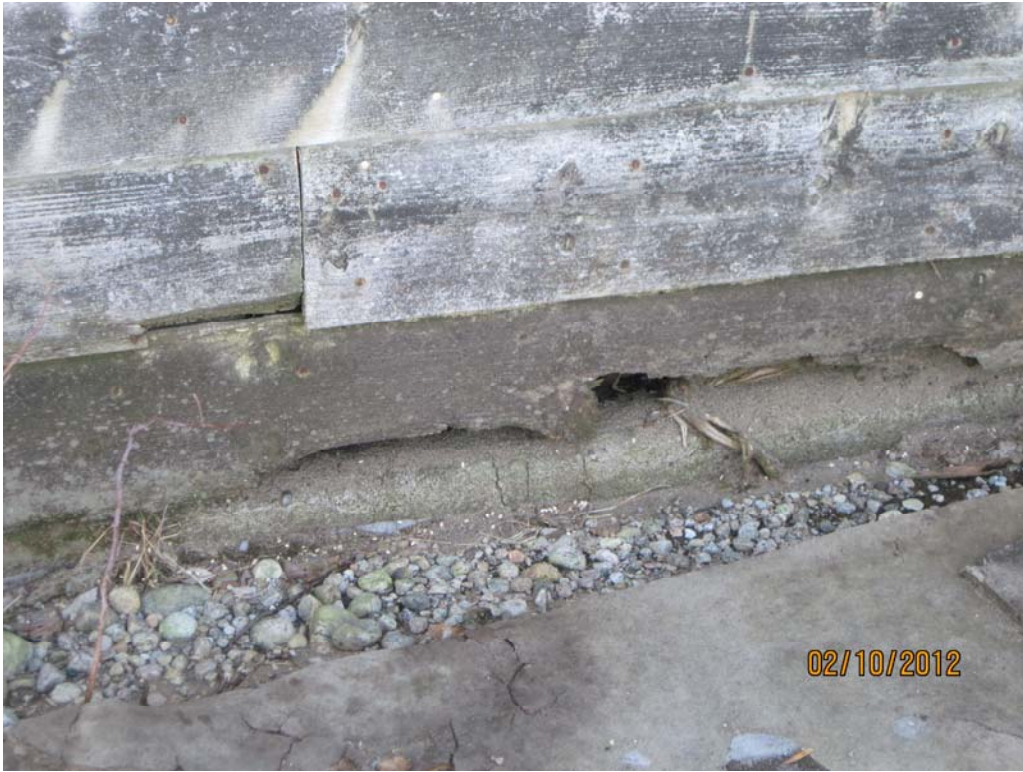
Photograph 19 – Scales Bldg. – Decayed Siding and Bottom Wall Plate

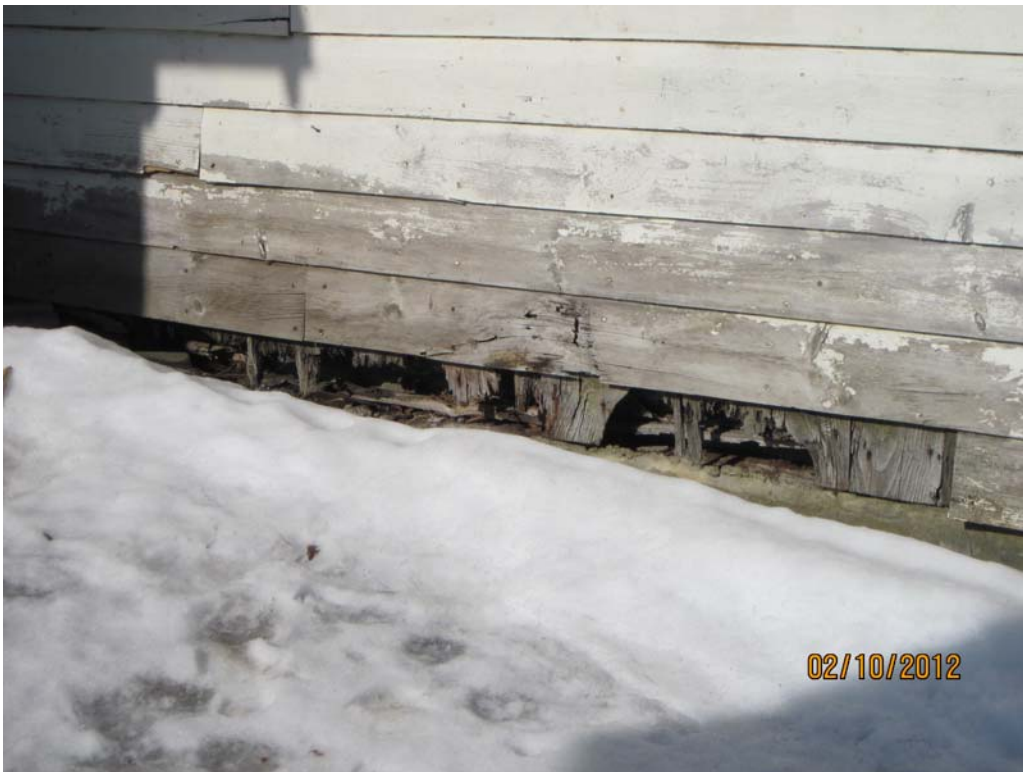
Photograph 20 – Scales Bldg. – Decayed Wall Plate and Post Base

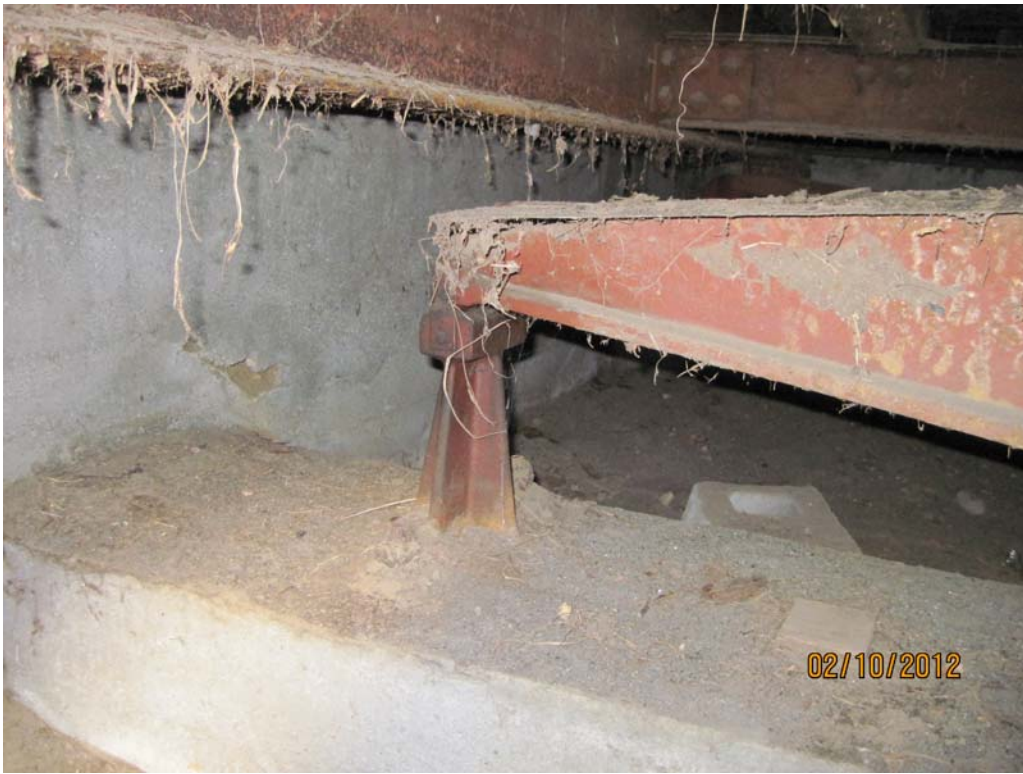
Photograph 21 – Scales Bldg. – Scale Pit Mechanism Bearing on Concrete Pier

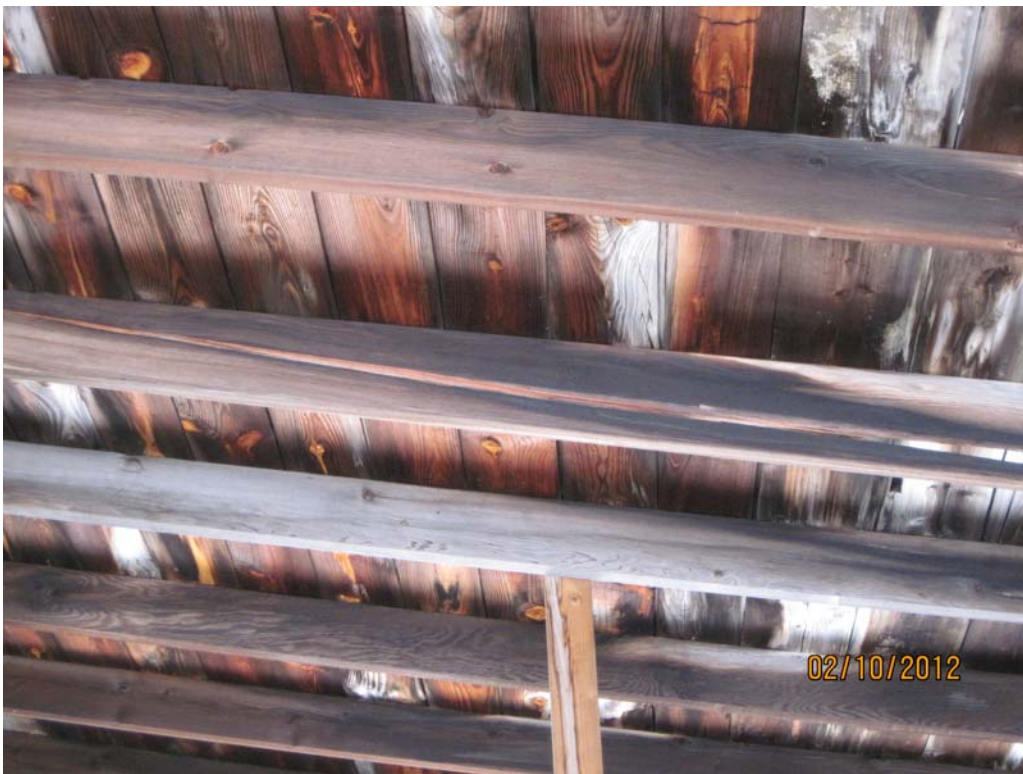
Photograph 24 – Scales Bldg. – Scale Pit Enclosure w/ Split Rafter and Decayed Planks

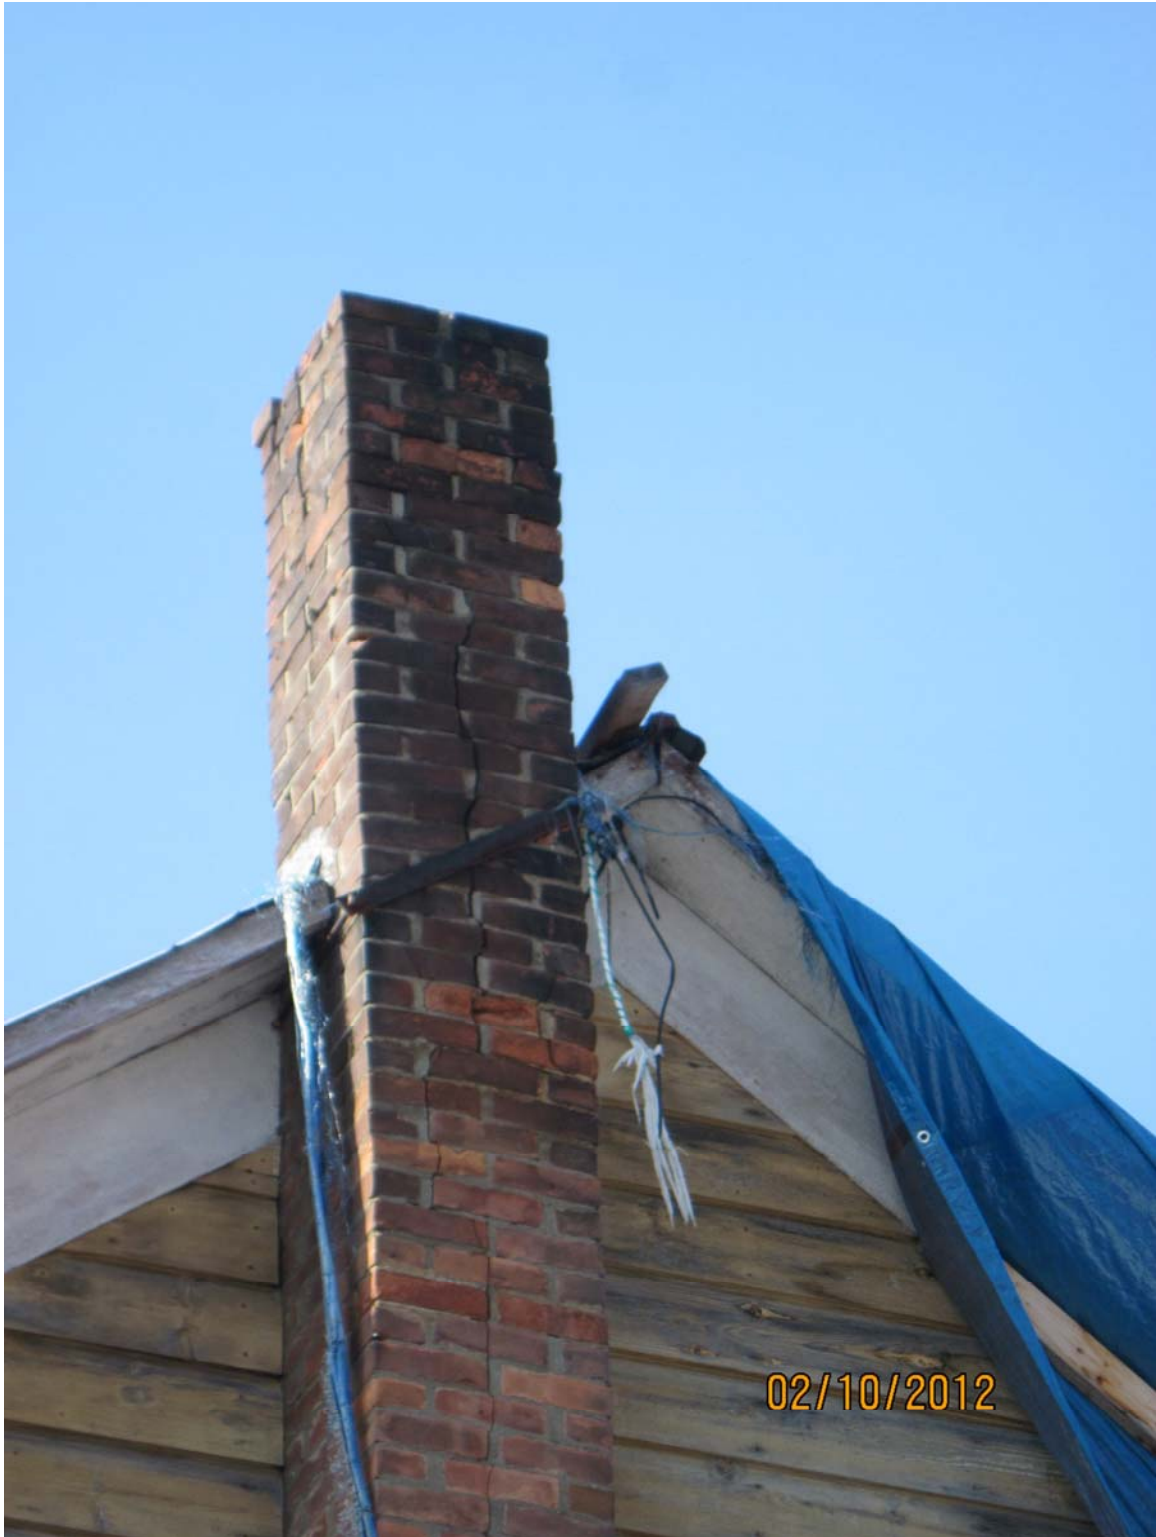
Photograph 25 – Scales Bldg. – Cracks in Brick Masonry Chimney

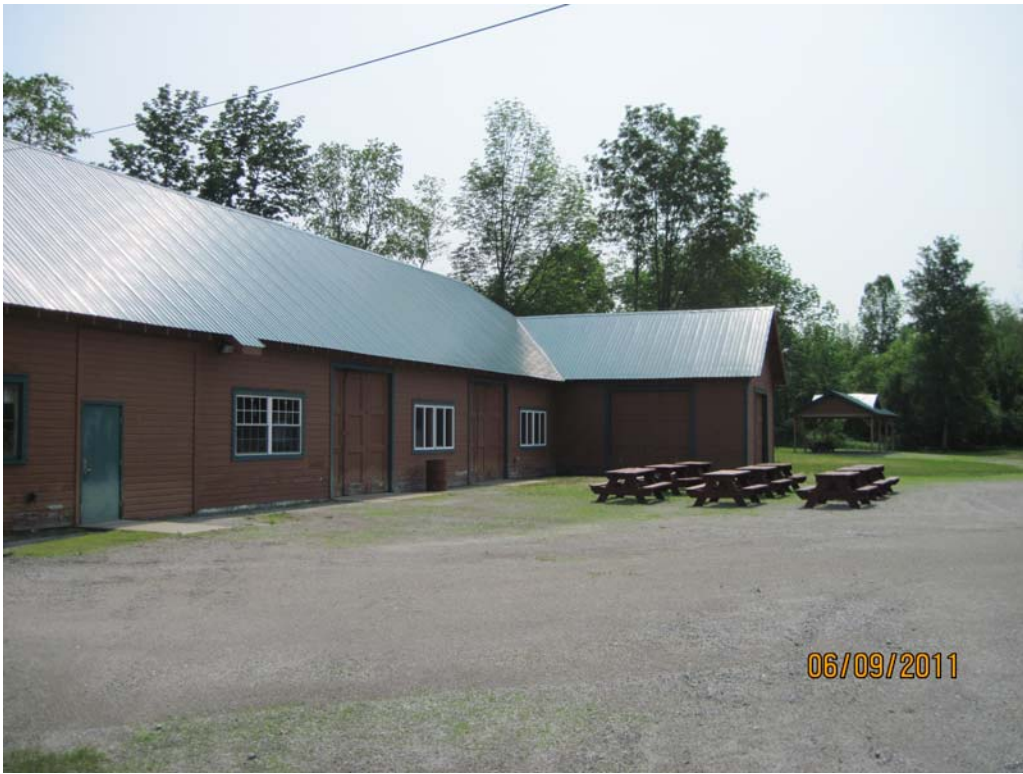
Photograph 26 – “T” Building – West Elevation, Note Height of Outside Grade Elevation
