Stewart Brook / Dula Pond Watershed Assessment

Prepared For the Town of Bolton

by the Warren County Soil and Water Conservation District

February 2012

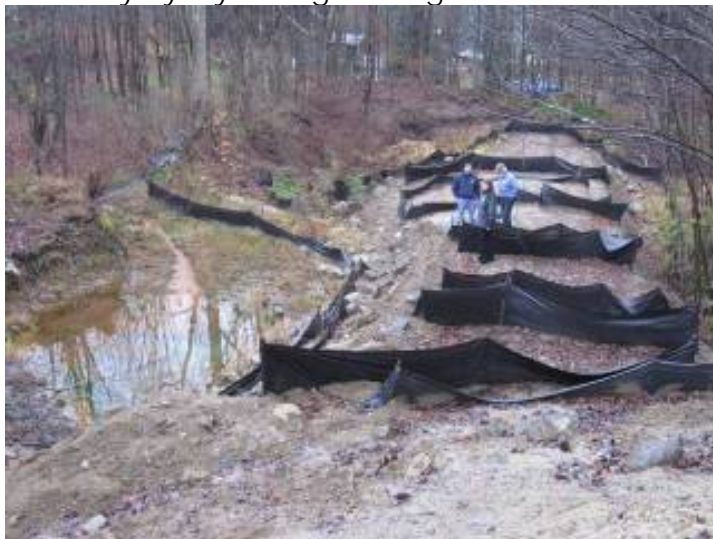
At the time of this current assessment, a considerable portion of the property was disturbed in some capacity related to construction activities. In some areas, the soils were unvegetated and unprotected. There was a series of silt fences being used as check dams that were in some cases filled to capacity or failing (see picture). During the assessment, numerous downstream landowners on the Stewart Brook voiced concerns over this the practices being employed at this location.

Not only is the site itself a concern for erosion and stream sedimentation, but the channel which conveys this tributary to the mainstem is also unstable. SWCD Manager Dave Wick was requested by the property owner Jeff Tennent on two occasions (2010 and 2011) to review the site and develop a solution. The District provided written recommendations to protect and improve this channel, but to date, these improvements have not been implemented. The result is that the site is still eroding and causing silt and sand to enter the brook, ultimately being deposited in Dula Pond.

The landowner should take immediate action to address the erosion and sedimentation issues associated with this property. The Town of Bolton should review the site and determine the need for the failing access road, and should direct the landowner to stabilize all aspects of the site. The earlier recommendations communicated through the District to the landowner in regard

to the outlet channel are still valid. The soil material placed in the wetland should be removed and the impacted wetland restored.

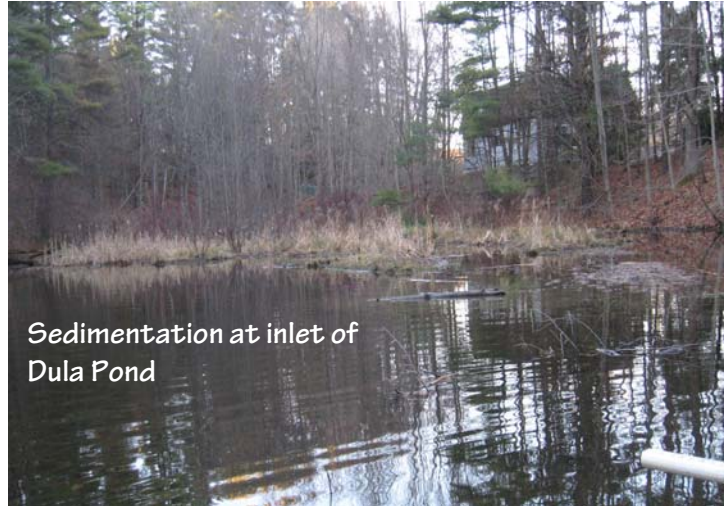
Visual inspections confirm that there is a fairly sizeable sediment delta at the inlet of Stewart Brook into Dula Pond. Based on the volume of sediment and the relatively rapid growth of this delta as reported by local landowners, it is fair to say that this delta results from upland erosion and stormwater runoff issues, exceeding what would be expected from natural conditions. This assertion is confirmed by the evidence of erosion issues within the stream system and on some private properties within the watershed.

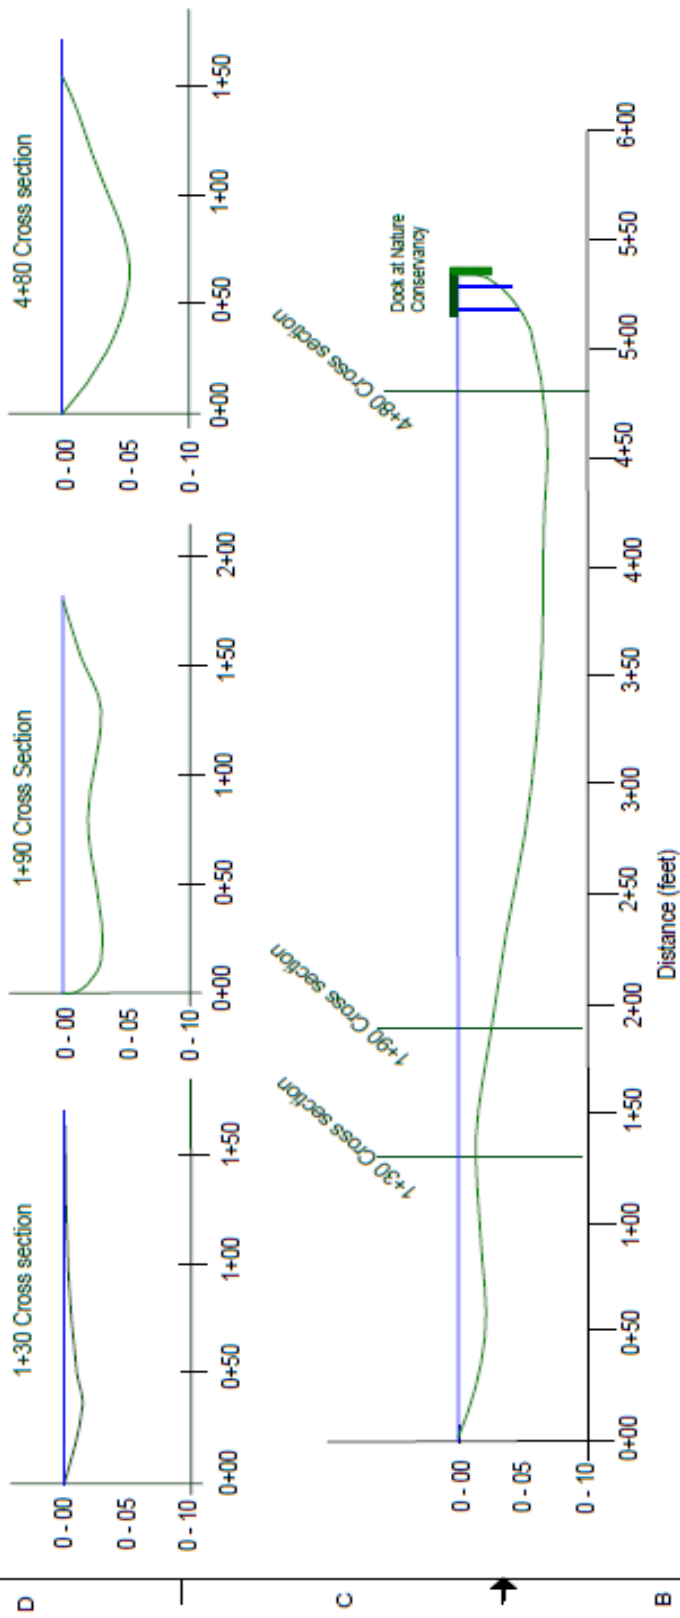
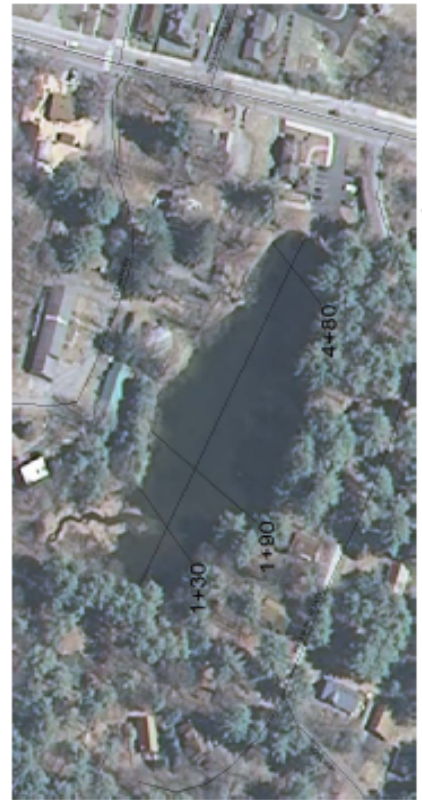
Dula Pond Bathymetry

SWCD staff took one longitudinal transect and three cross section transects of pond depths in Dula Pond to get an overall status of the general depths in the pond at various locations (Appendices D and E). The pond depth for the first 200 feet or so of the pond below the inlet ranges from zero to three feet, and then the depth slowly drops off to a maximum depth of six to seven feet towards the outlet. The SWCD does not have historical information on original pond depth or excavation, so comparisons to original condition are not reported herein.
