BUILDING CONDITION ASSESSMENT REPORT

Countryside Adult Home

353 Schroon River Road
Town of Warrensburg, New York

May 6, 2019

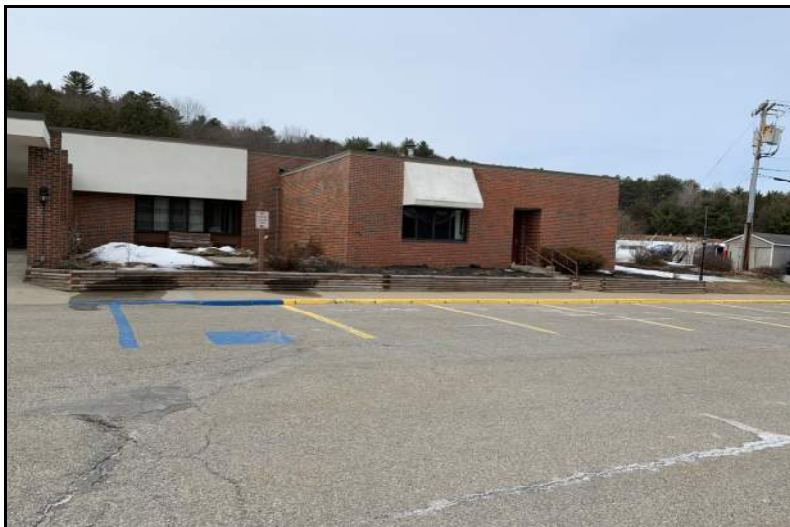
Two dedicated handicap parking stalls are located adjacent to the main building entrance on the east side of the building. The handicap parking stalls do not currently have signage that meets Americans with Disabilities Act (ADA) requirements. One of the dedicated handicap stalls should also be designated as a van assessable parking space. During the site reconnaissance, it was noted that additional parking is needed to accommodate the facility parking needs.

Photograph No. 3: Northeast corner of the building with handicap parking space (currently not meeting ADA signage standards).

- Signage meeting ADA standards should be installed for the dedicated handicap accessible parking areas.
- Provide additional parking area to meet facility needs.
- County forces should be considered for completion of site work (such as the items noted above) as a cost saving measure.

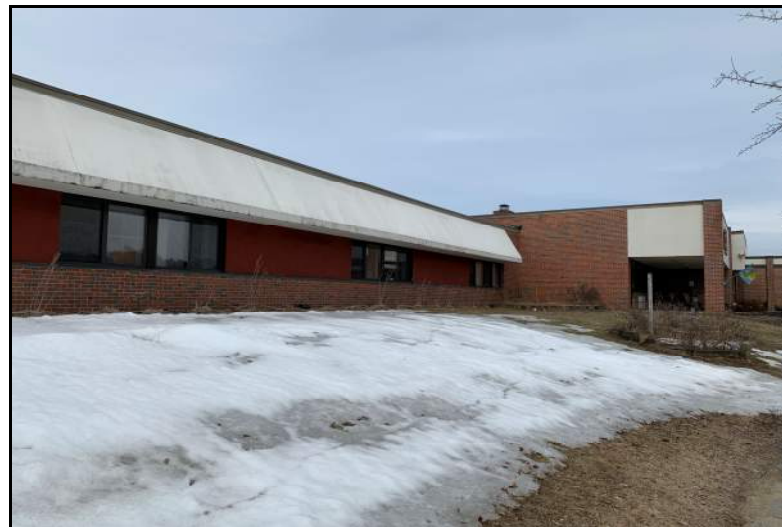
Photograph No. 4: Southeast side of the building with stained insulated plaster veneer overhangs.

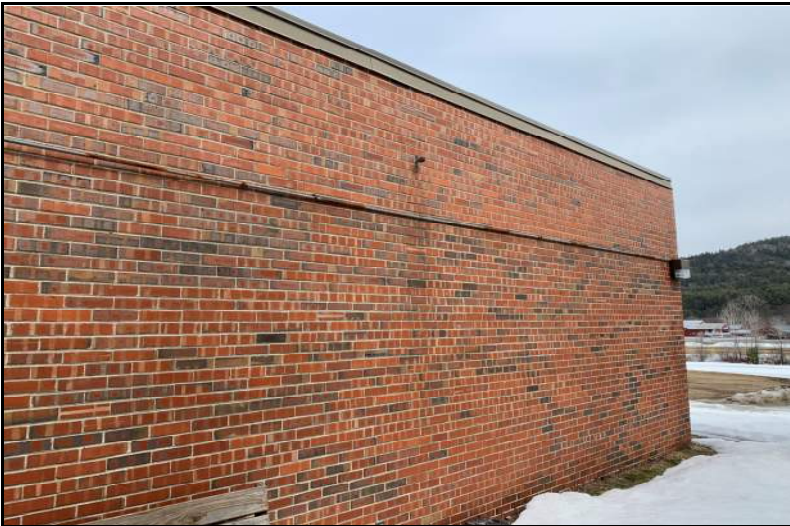
Photograph No. 6: Brick and mortar veneer with staining at south side of the building.

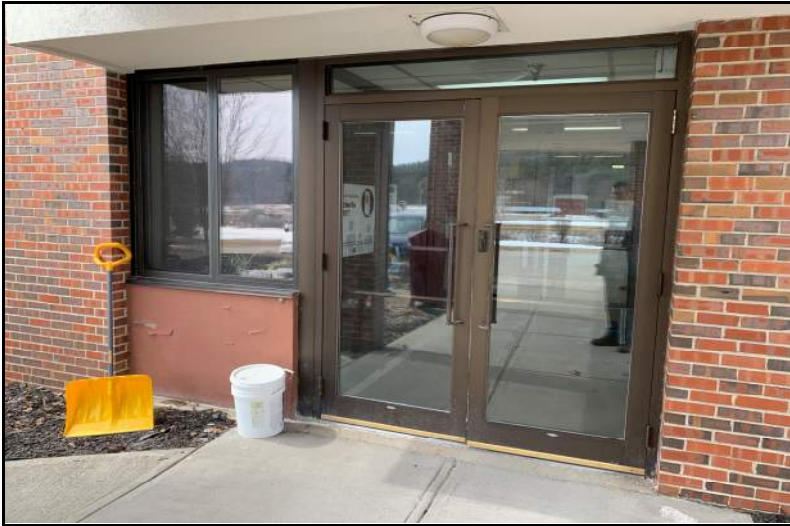
- The main entrance doors are in need of upgrades or replacement. The locks at the door are not operational. The handicap automatic opener controls operate in a manner that could cause safety concerns to the residents and trap them in the vestibule.

Photograph No. 7: Main entrance doors.

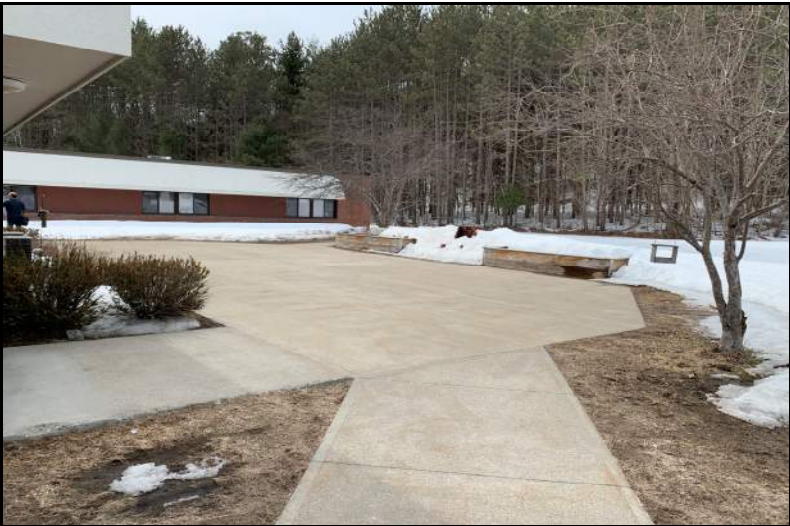
A covered concrete patio is located at the main building entrance on the east side of the building. An additional open-air patio is located west of the Dining Room addition. The concrete at the patios was observed in good condition but there are a few areas at the edge of the open-air patio where the concrete was delaminating or damaged by moving lawn equipment over it. Wooden picnic tables are provided at the open-air patio for resident use. During the site visit most of the picnic tables were covered in snow.

Photograph No. 9: Concrete patio west of dining area.

- Areas of damaged concrete at the open-air patio should be repaired/patched.
- The wooden picnic tables should be re-stained/painted. Additional composite picnic tables could

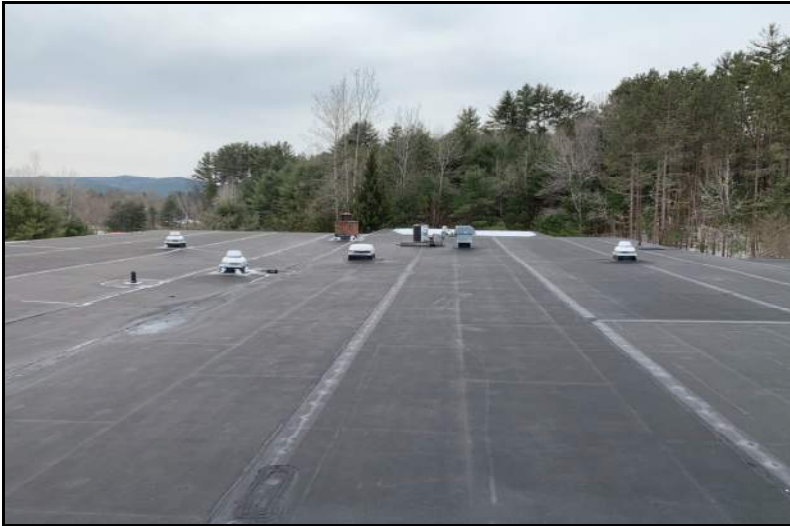
- Resident Room walls do not extend to the roof deck and are not insulated. Noise easily transmits between Resident Rooms.
- The existing roof was replaced approximately 15-20-years ago and has been patched several times. Flooding occurs at the roof due to buildup of ice and snow.

Photograph No. 11: Existing EPDM roofing.

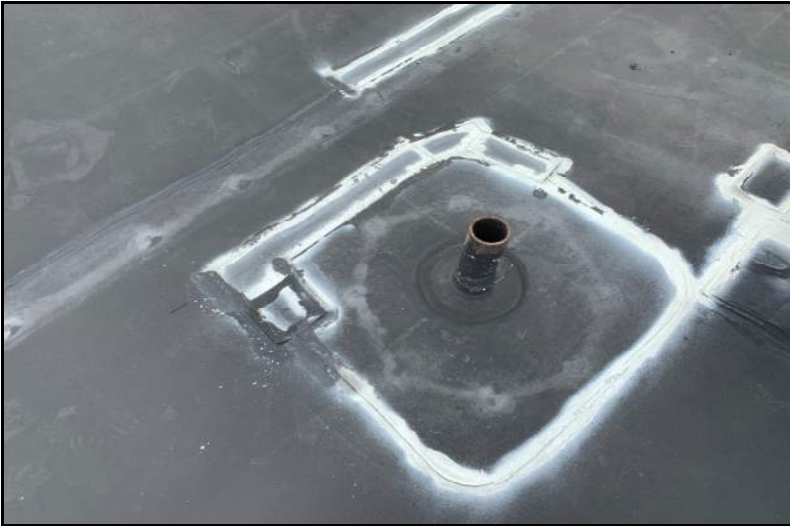
Photograph No. 12: Typical patches at existing roofing.

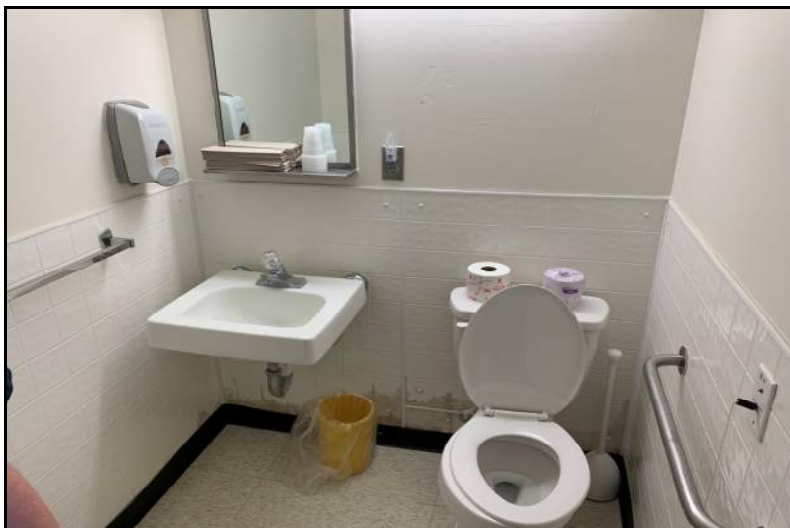
Photograph No. 19: Damaged FRP wainscot at Resident Bathroom.

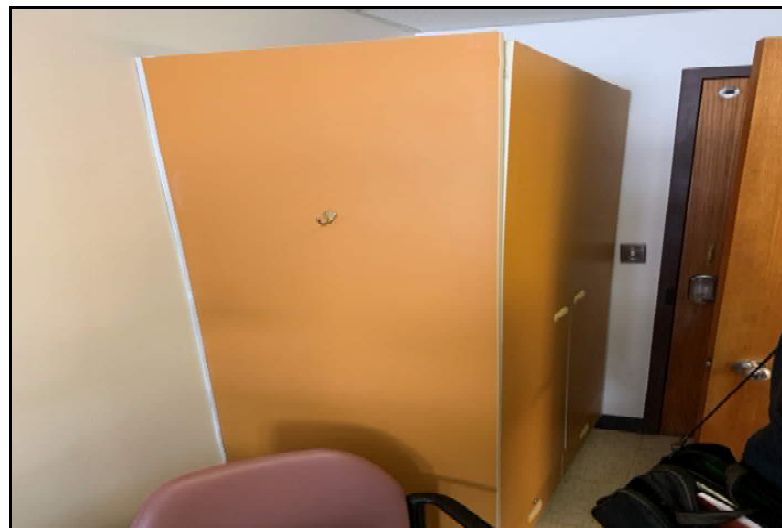
- Resident Room wardrobes are mostly original to the building although some have been replaced. The current arrangement of the wardrobes near the room entrances is a safety concern since the bottom drawer can be opened and used to block staff access into the rooms.

Photograph No. 20: Resident Room wardrobes

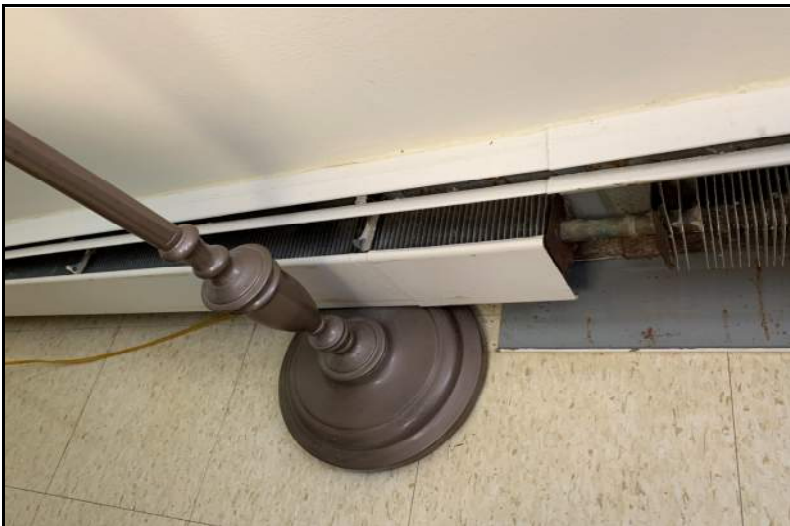
Photograph No. 21: Fin tube baseboard with damaged enclosure at Resident Room.

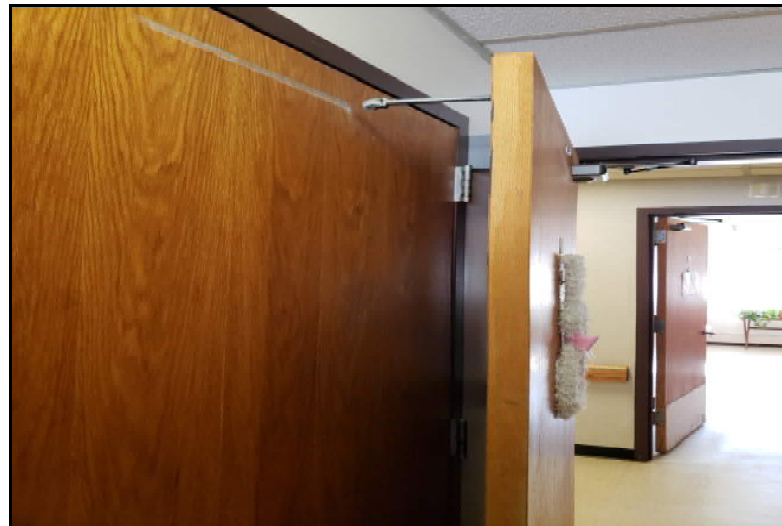
- A single ceiling mounted light fixture is located at the Resident Room's and does not provide adequate light.
- Magnetic door hold opens were added to Resident Room entry door's during a prior project. When the door is held open it creates an awkward and unsafe condition with the adjacent Resident Room bathroom door.

Photograph No. 22: Typical Resident Room entry door with hold open.

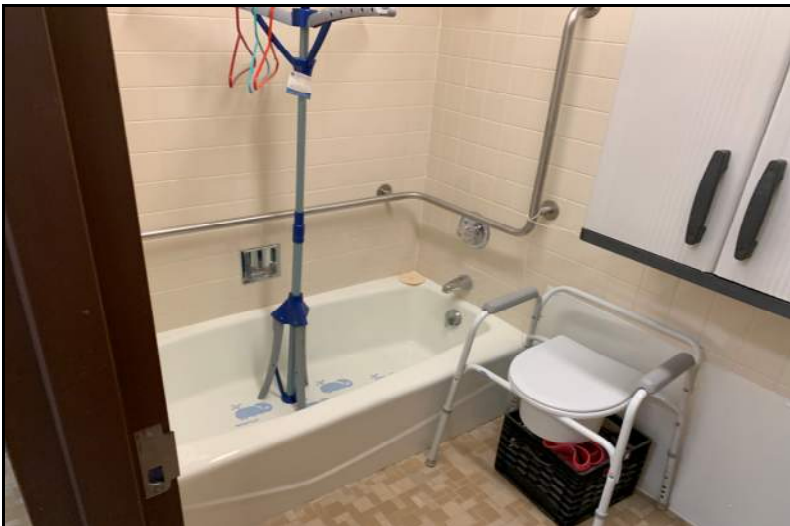
- Currently the tubs in the Shower Room are not used. It is difficult to assist persons while using the tubs. A walk-in whirlpool tub should be considered as a replacement. Added heat and ventilation are needed in the Shower Rooms.

Photograph No. 25: Existing tub not currently utilized in Shower Room.

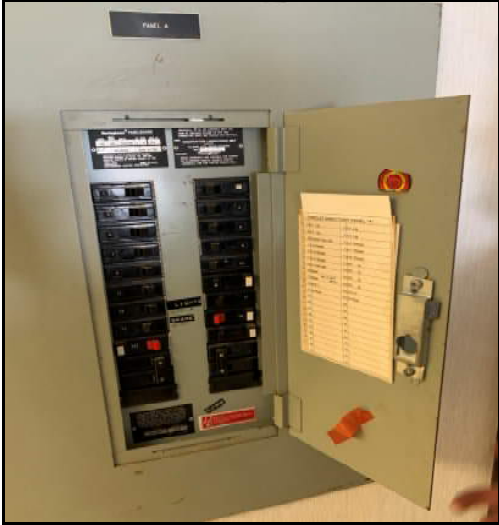
- The nurses call system was recently repaired. A short in the system was causing the system to malfunction.
- Electric panel boxes in the corridors are not secure due to inoperable locks. It is desired to have corridor lighting controls moved to a central location.

Photograph No. 36: Typical Corridor subpanel.
