POTTERSVILLE WATER DISTRICT STUDY

Preliminary Engineering Report

Town of Chester, NY

Date: May 12, 2023

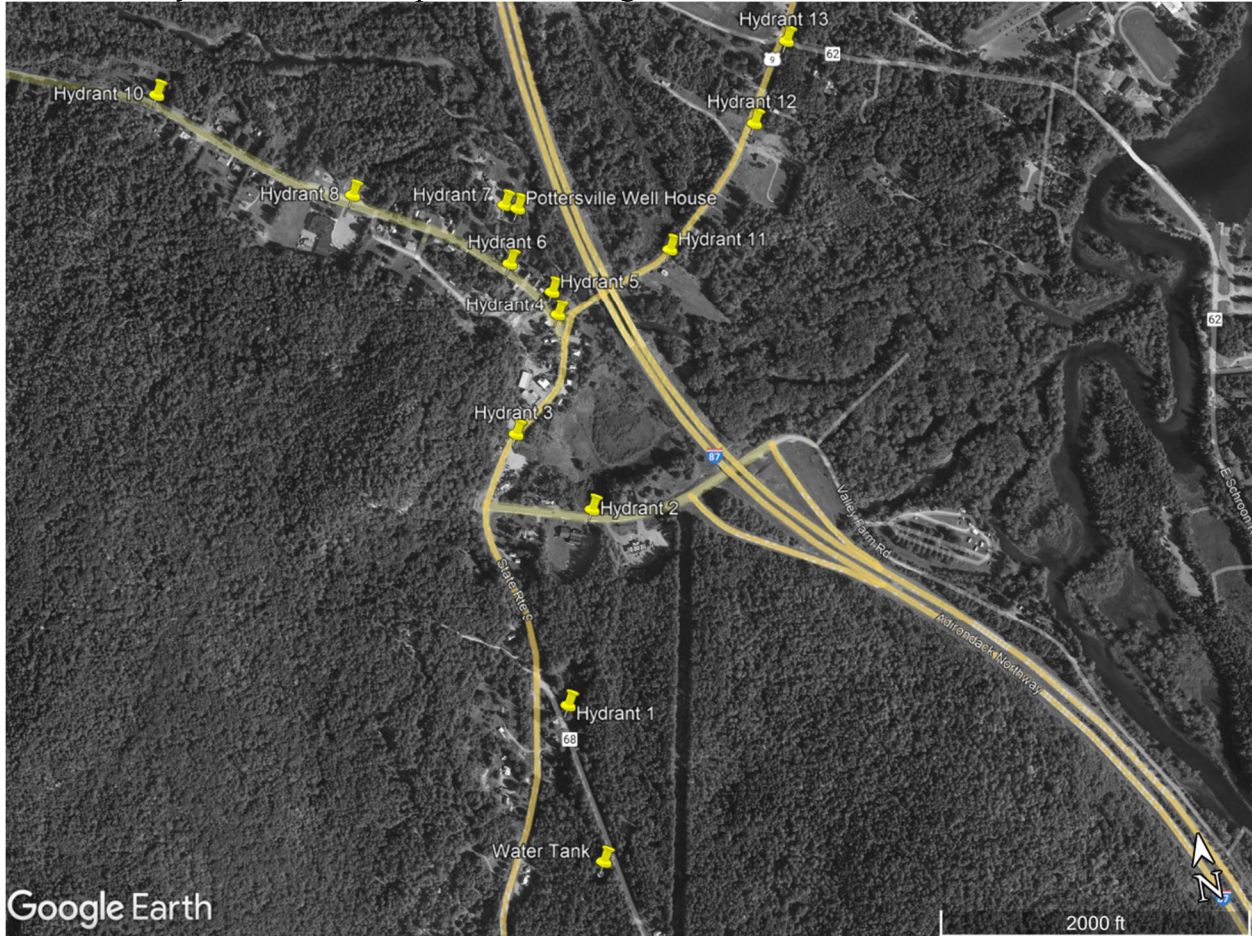
Figure 2: Hydrant Location Map¹

It is believed that test number 2 shown in the fire flow testing table did not cause a residual pressure drop of at least 10psi, and therefore, the results may not be relied upon for this specific test. Test 2 may represent a higher theoretical flow available that can be achieved by the existing system. Additional hydrant testing locations were attempted, but due to multiple issues with existing hydrants (gate valve isolated with debris in the valve box, hydrant caps unable to be removed, etc.), the additional testing could not be completed.

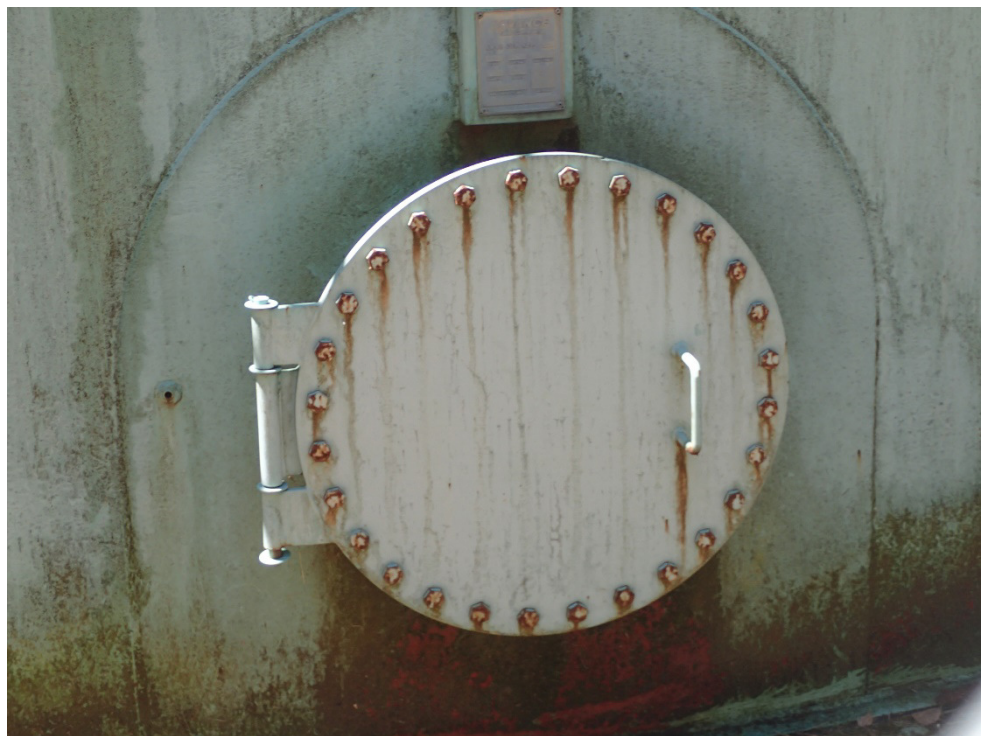
Image #7

Description:
24" Entry Hatch appeared to be in fair condition with a moderate amount of corrosion. No weather stripping was observed.

It is recommended that the Town have another tank inspection completed and the sediment cleaned out of the tank as soon as possible. Some additional questions remain if there is any cathodic protection within the tank for corrosion resistance, and condition of the tank floor. It may also be recommended to have a structural evaluation of the tank be completed to ensure the tank could be rehabilitated in the future to prolong its useful life. The overflow screen and vent screens should be evaluated that they are in good condition to ensure public safety. A gasket and new lock should also be installed on the roof access hatch.

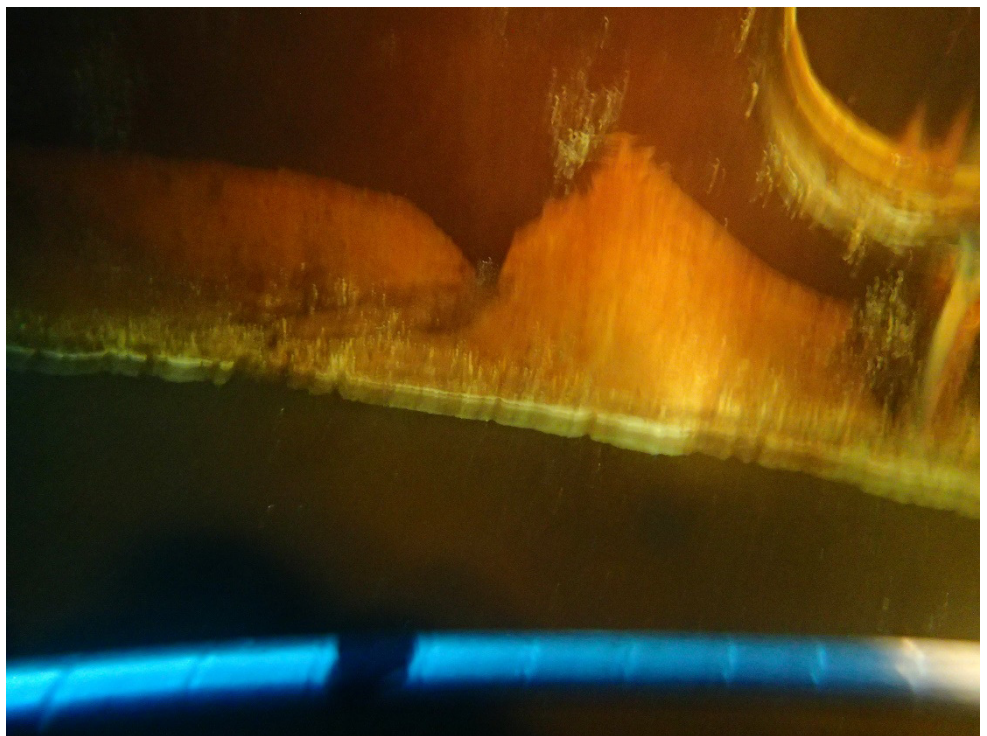
Image #13

Description:
Wall appeared to be in fair condition with a moderate amount of corrosion and heavy staining observed.

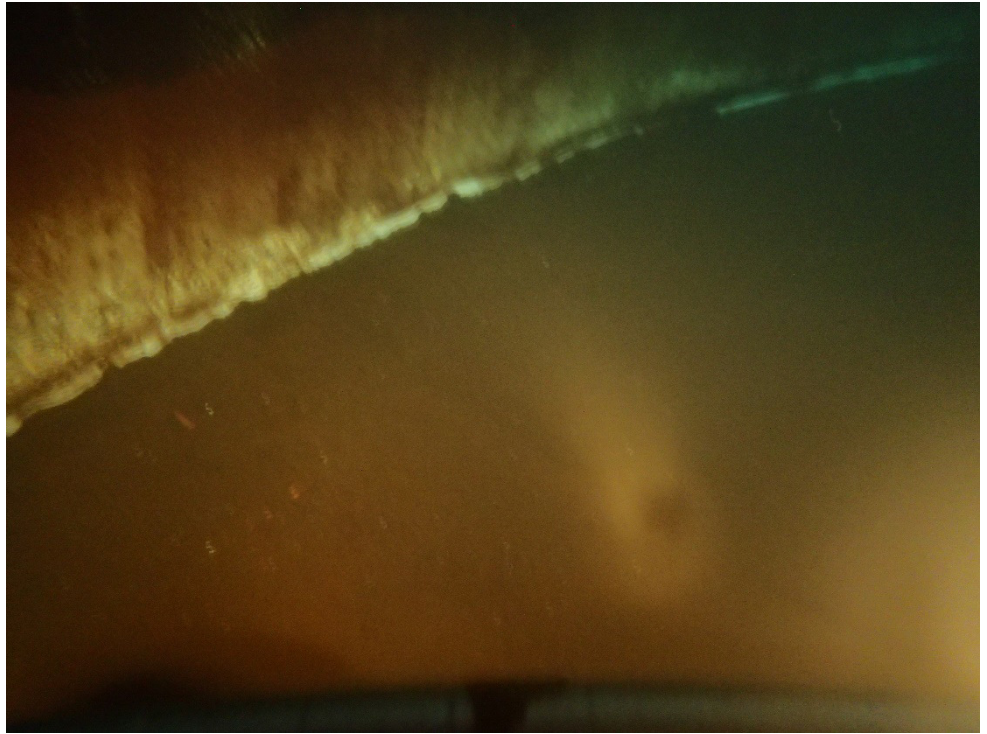
Image #16

Wall 3:00

Description:
Wall appeared to be in fair condition with a moderate amount of corrosion and heavy staining observed.

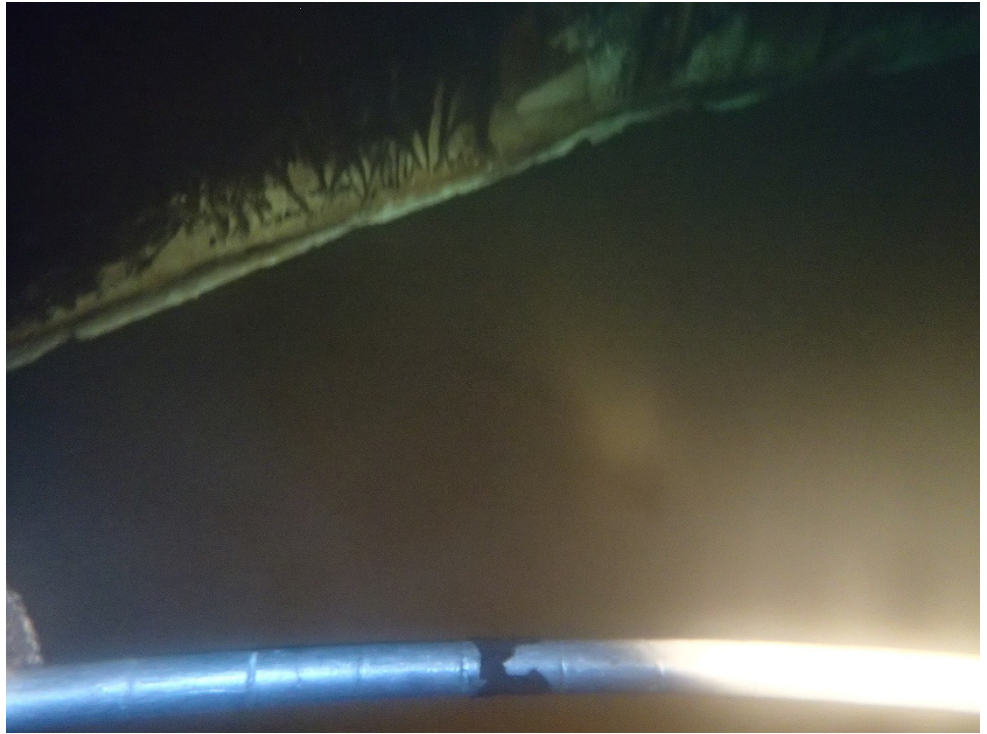
Image #18

Wall 6:00

Description:
Wall appeared to be in fair condition with a moderate amount of corrosion and heavy staining observed.

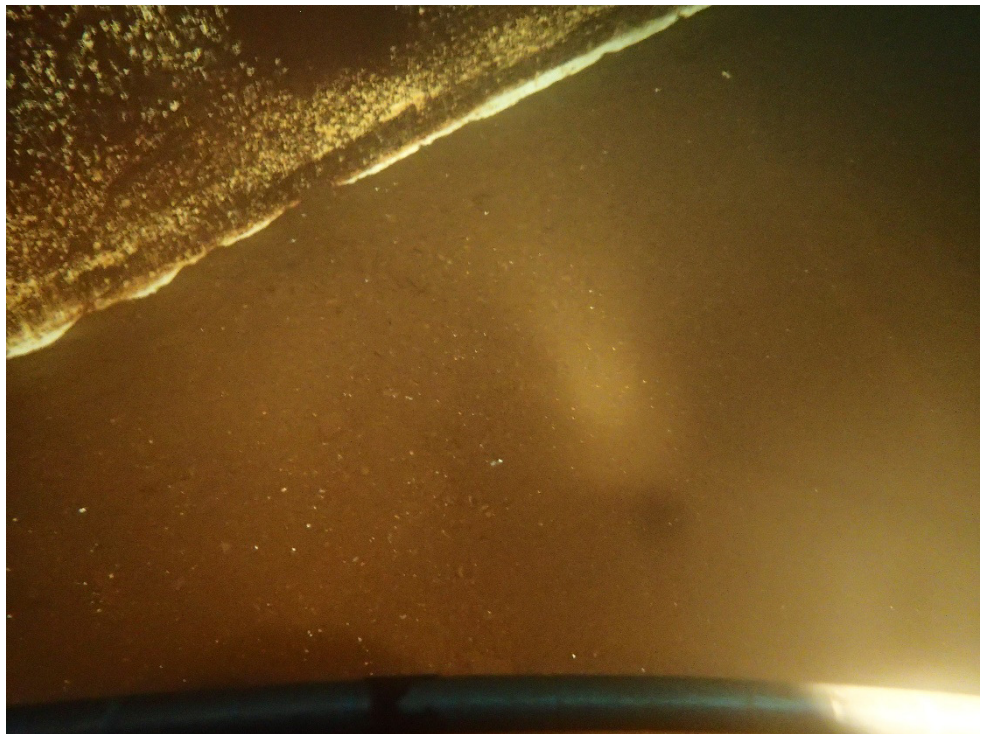
Image #21

Description:
Wall appeared to be in fair condition with a moderate amount of corrosion and heavy staining observed.

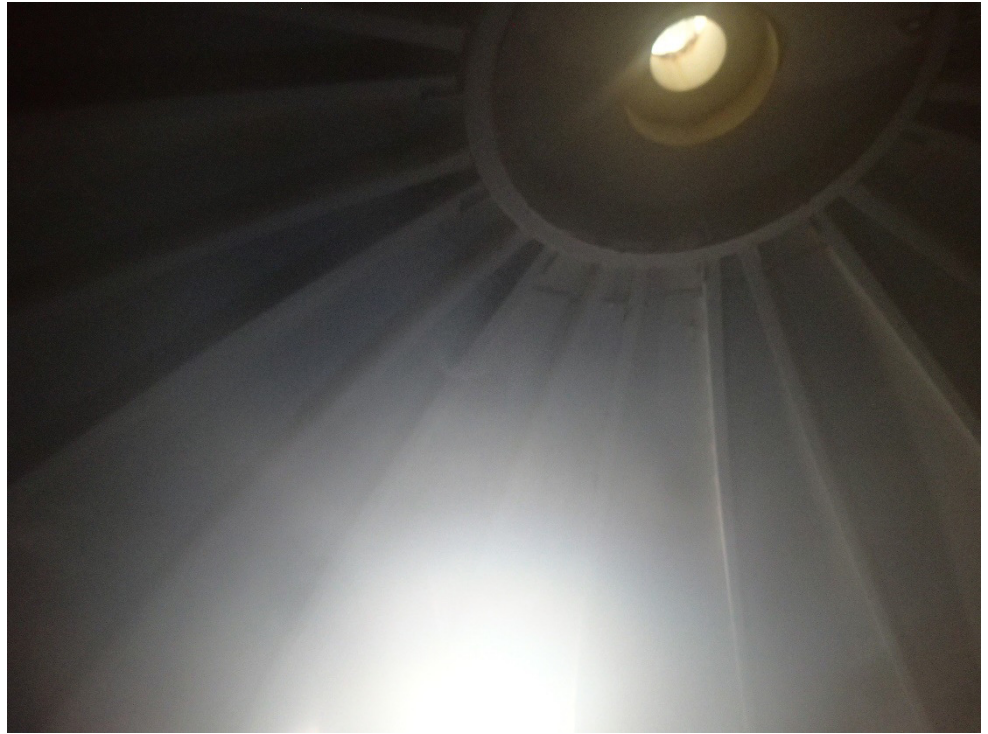
Image #24

Ceiling 3:00

Description:
Ceiling appeared to be in fair condition with a minor amount of corrosion.

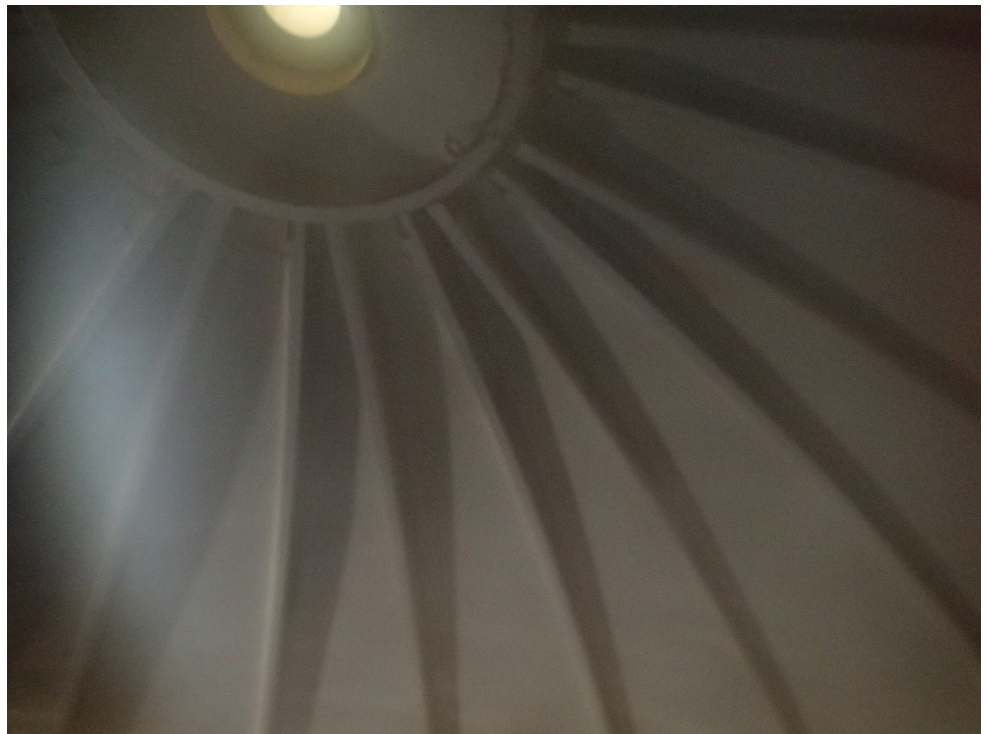
Image #25

Description:
Ceiling appeared to be in fair condition with a minor amount of corrosion.

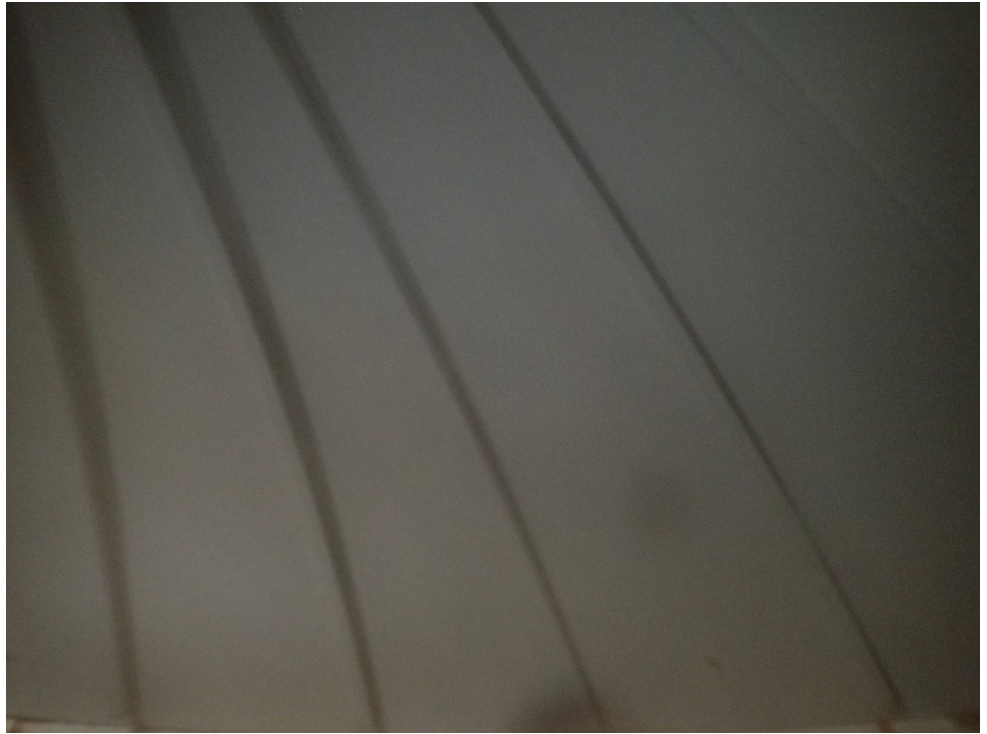
Image #26

Ceiling 9:00

Description:
Ceiling appeared to be in fair condition with a minor amount of corrosion.

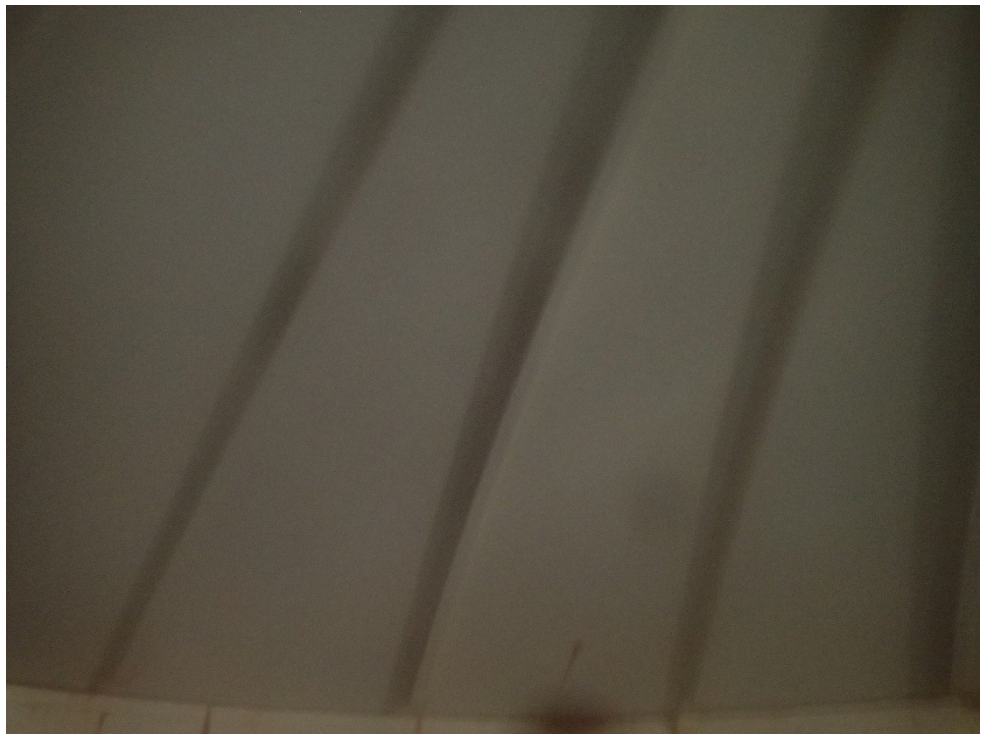
Image #27

Description:
24"x5" Overflow
appeared to be in good
condition with a minor
amount of corrosion.
