BUILDING CONDITION ASSESSMENT REPORT

Countryside Adult Home

353 Schroon River Road
Town of Warrensburg, New York

May 6, 2019
Revision 1

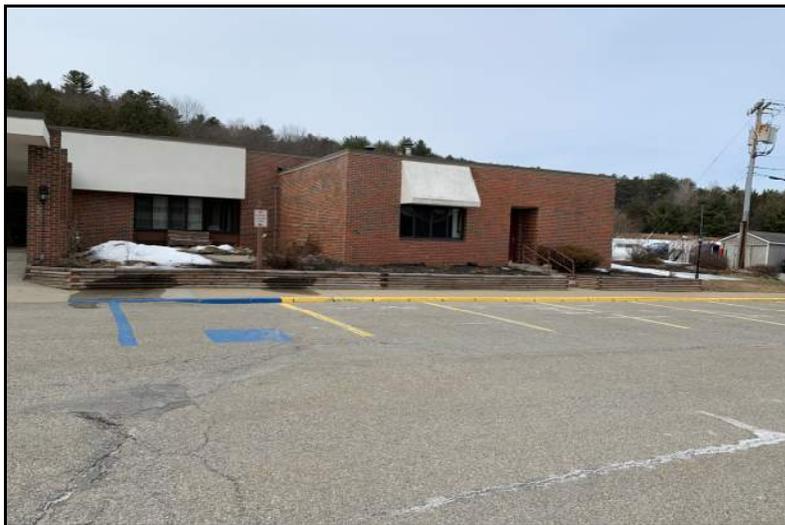
Two dedicated handicap parking stalls are located adjacent to the main building entrance on the east side of the building. The handicap parking stalls do not currently have signage that meets Americans with Disabilities Act (ADA) requirements. One of the dedicated handicap stalls should also be designated as a van assessable parking space. During the site reconnaissance, it was noted that additional parking is needed to accommodate the facility parking needs.

Photograph No. 3: Northeast corner of the building with handicap parking space (currently not meeting ADA signage standards).

- Signage meeting ADA standards should be installed for the dedicated handicap accessible parking areas.
- Provide additional parking area to meet facility needs.
- County forces should be considered for completion of site work (such as the items noted above) as a cost saving measure.

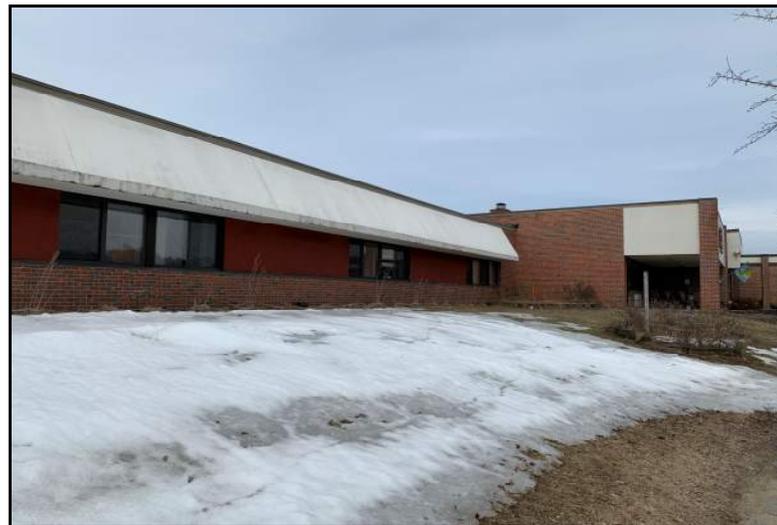
Photograph No. 4: Southeast side of the building with stained insulated plaster veneer overhangs.

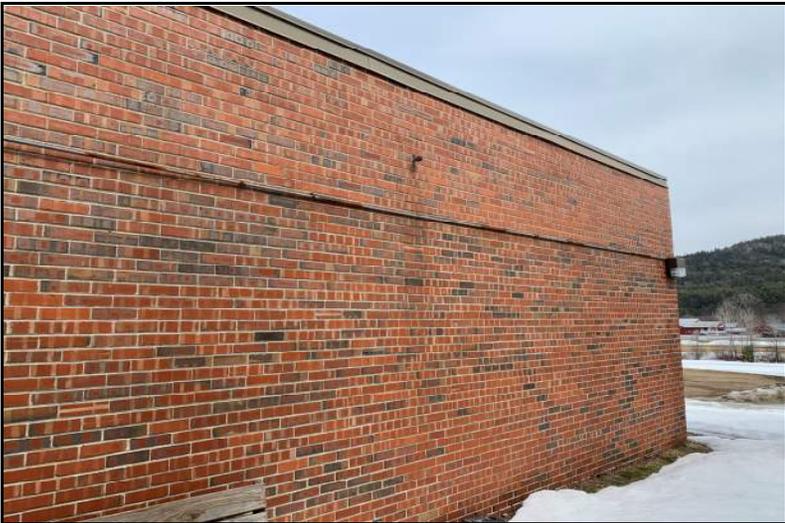
Photograph No. 6: Brick and mortar veneer with staining at south side of the building.

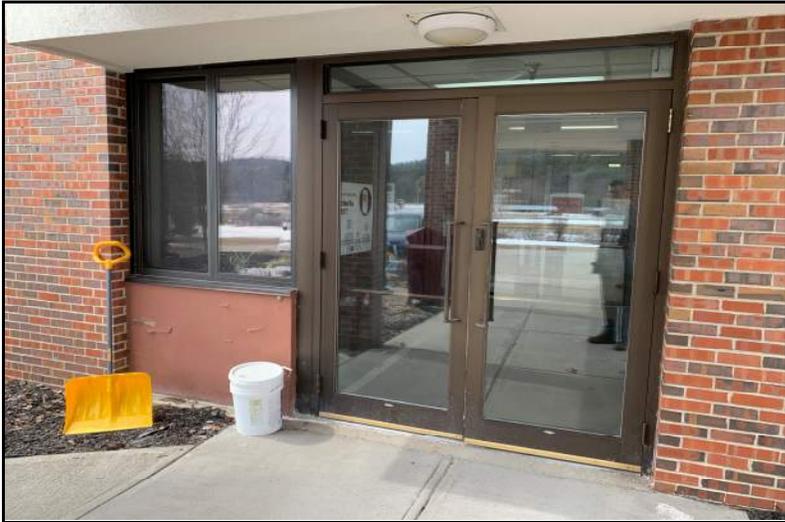
- The main entrance doors are in need of upgrades or replacement. The locks at the door are not operational. The handicap automatic opener controls operate in a manner that could cause safety concerns to the residents and trap them in the vestibule.

Photograph No. 7: Main entrance doors.

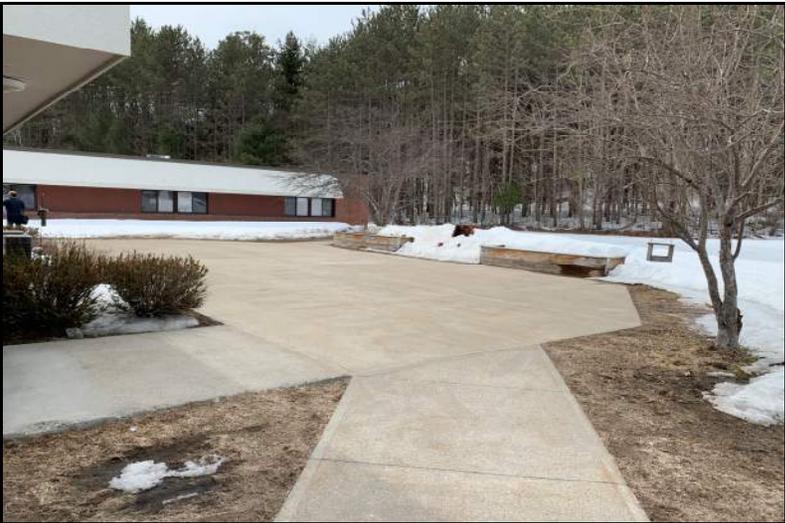
A covered concrete patio is located at the main building entrance on the east side of the building. An additional open-air patio is located west of the Dining Room addition. The concrete at the patios was observed in good condition but there are a few areas at the edge of the open-air patio where the concrete was delaminating or damaged by moving lawn equipment over it. Wooden picnic tables are provided at the open-air patio for resident use. During the site visit most of the picnic tables were covered in snow.

Photograph No. 9: Concrete patio west of dining area.

- Areas of damaged concrete at the open-air patio should be repaired/patched.
- The wooden picnic tables should be re-stained/painted. Additional composite picnic tables could

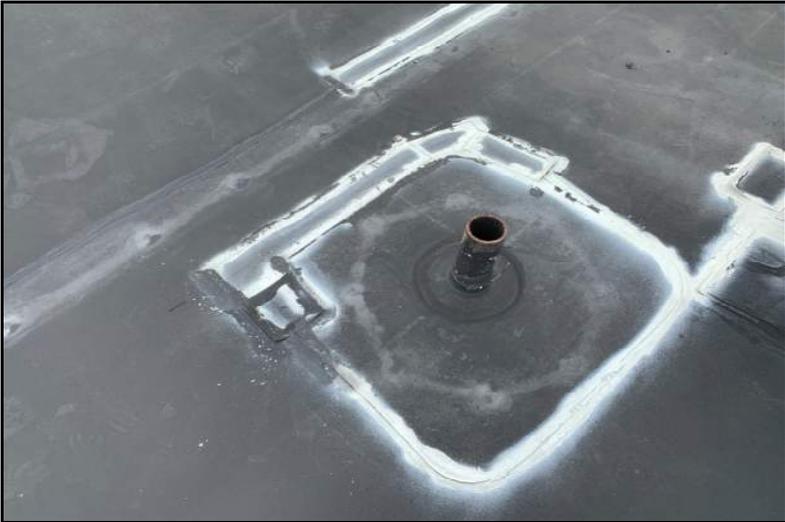
- Resident Room walls do not extend to the roof deck and are not insulated. Noise easily transmits between Resident Rooms.
- The existing roof was replaced approximately 15-20-years ago and has been patched several times. Flooding occurs at the roof due to buildup of ice and snow.

Photograph No. 12: Typical patches at existing roofing.

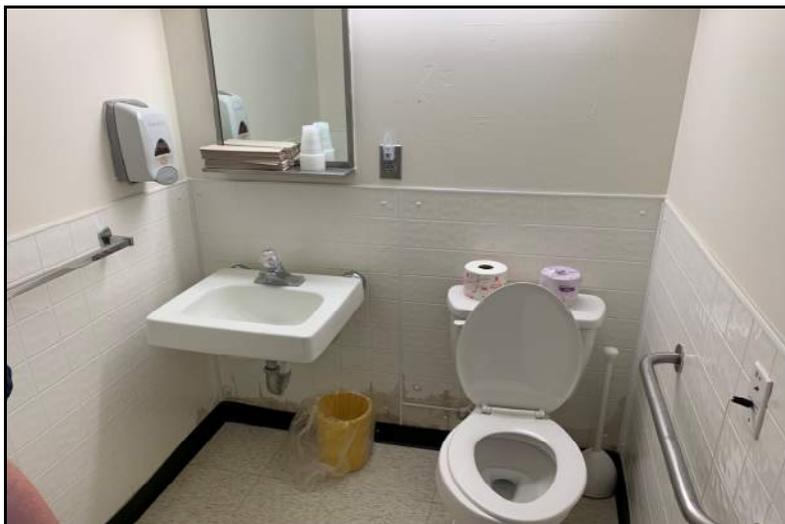
Photograph No. 19: Damaged FRP wainscot at Resident Bathroom.

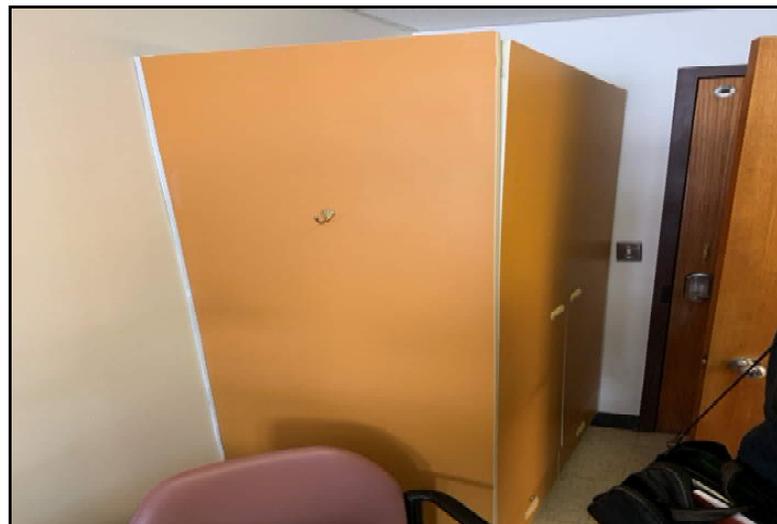
- Resident Room wardrobes are mostly original to the building although some have been replaced. The current arrangement of the wardrobes near the room entrances is a safety concern since the bottom drawer can be opened and used to block staff access into the rooms.

Photograph No. 20: Resident Room wardrobes

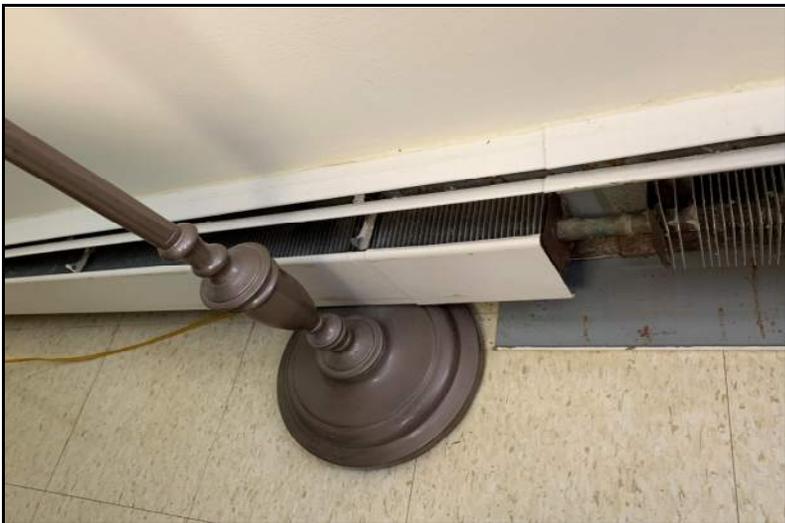
Photograph No. 21: Fin tube baseboard with damaged enclosure at Resident Room.

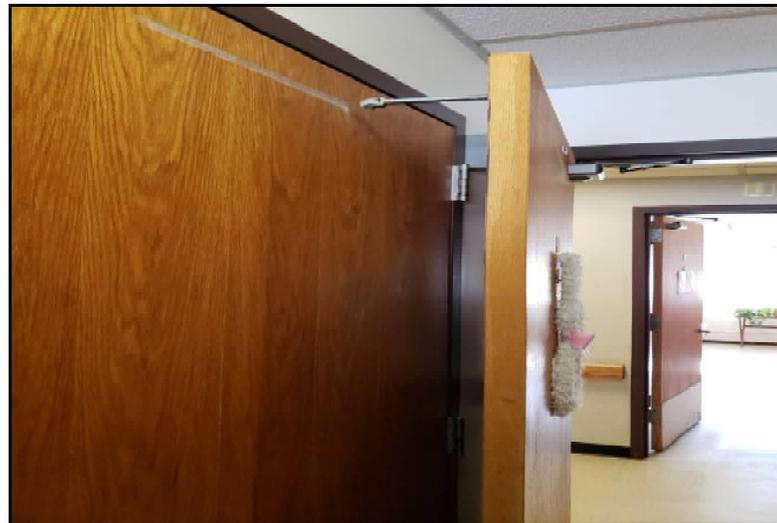
- A single ceiling mounted light fixture is located at the Resident Room's and does not provide adequate light.
- Magnetic door hold opens were added to Resident Room entry door's during a prior project. When the door is held open it creates an awkward and unsafe condition with the adjacent Resident Room bathroom door.

Photograph No. 22: Typical Resident Room entry door with hold open.

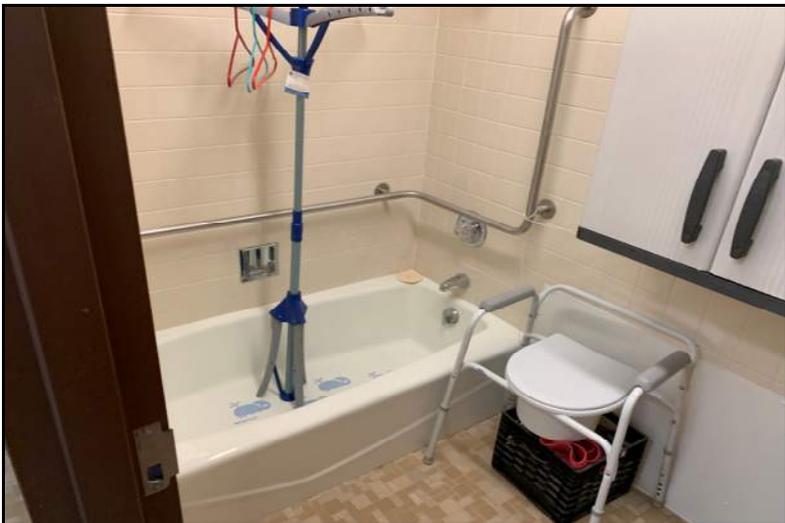
- Currently the tubs in the Shower Room are not used. It is difficult to assist persons while using the tubs. A walk-in whirlpool tub should be considered as a replacement. Added heat and ventilation are needed in the Shower Rooms.

Photograph No. 25: Existing tub not currently utilized in Shower Room.

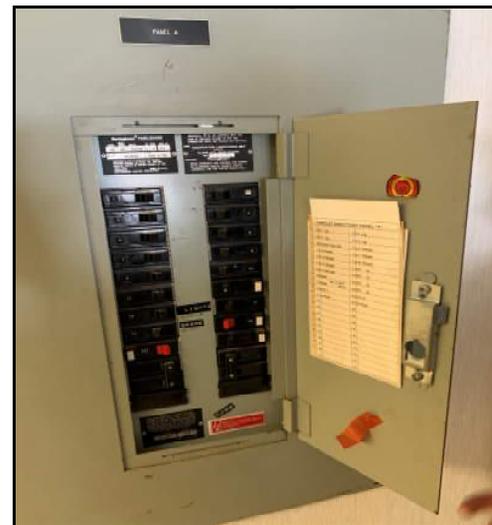
- The nurses call system was recently repaired. A short in the system was causing the system to malfunction.
- Electric panel boxes in the corridors are not secure due to inoperable locks. It is desired to have corridor lighting controls moved to a central location.

Photograph No. 36: Typical Corridor subpanel.

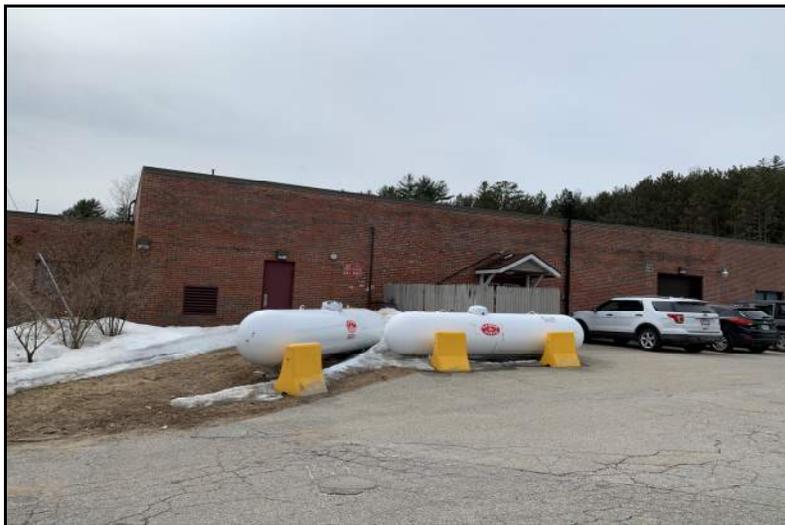
A 3,000-gallon above ground fuel oil storage tank and three above ground propane tanks are also located in the north parking area. The propane storage tanks are located north of the dumpster enclosure and do not have permanent foundations.

Photograph No. 39 Existing propane storage tank.

- The siding and roofing on the wood framed storage shed should be replaced.
- The above ground propane storage tanks should be relocated to a permanent concrete foundation/slab. The addition of shrubbery around the tanks would provide a visual barrier and improve the aesthetics of the north side of the building which is first seen by persons visiting the site.
