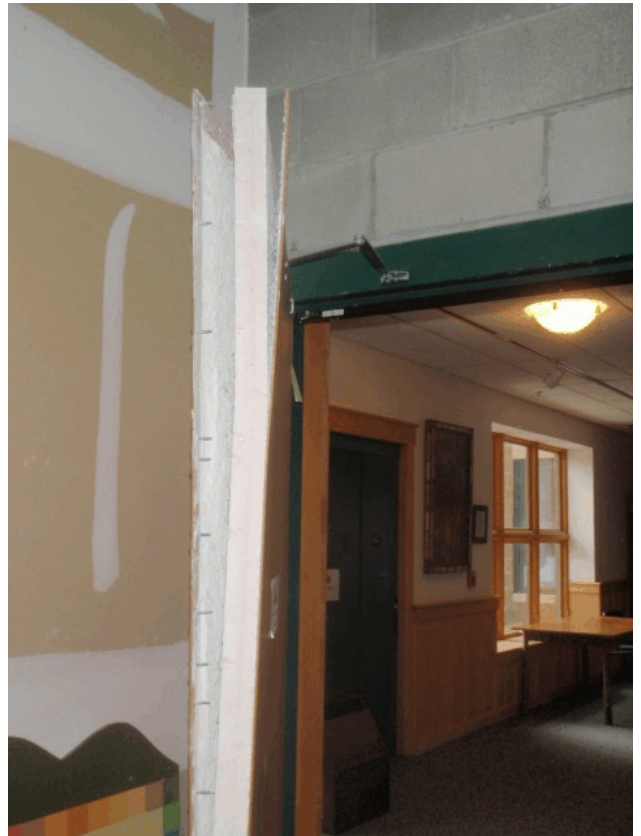
Lower level settling with moisture damage

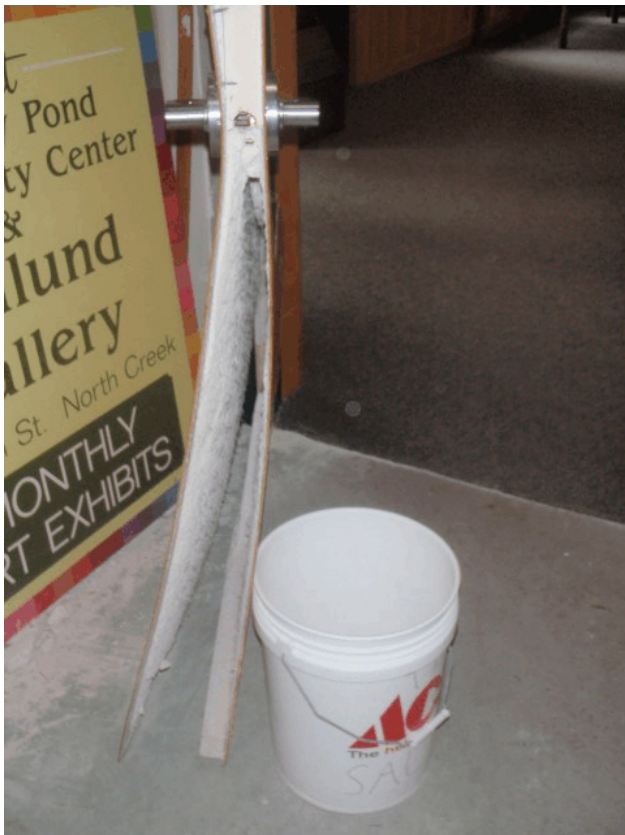
Moisture damaged fire door to be replaced

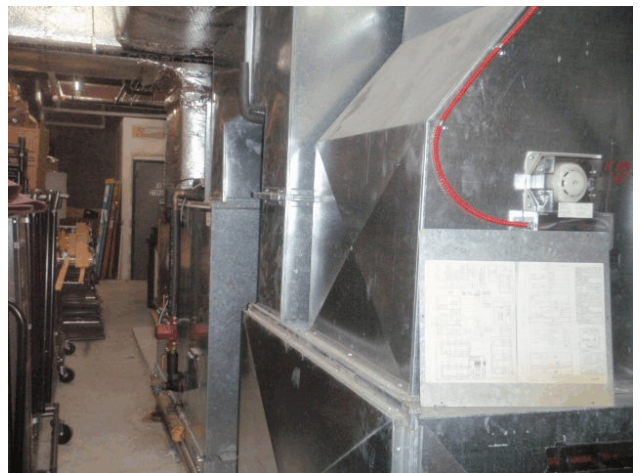
Heat pumps located in lower level with associated ductwork. 2 of the 3 pumps are inoperative.
