BALDWIN

St. Pl. Ave. No. 49

Name of Owner
TAX ID # 302.12-16-1

Labor and Mat'l. Report 1981

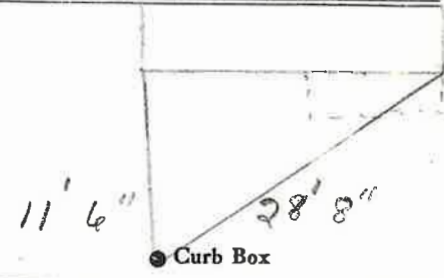
6" Main Elev. of Main at tap 5'

Gate at • Gate at •
20' to main
• Curb Box
