BALDWIN St. Pl. Ave. No. 50

Name of Owner  
TAX ID # 302.12-13-56

Labor and Mat'l. Report 19

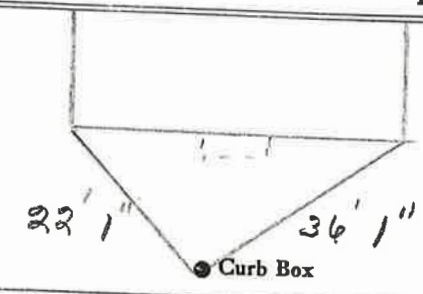
6'' Main Elev. of Main at tap 5'

Gate at ● ● Gate at

● Curb Box
