St.  
Pl.  
Ave. No. 80

Labor and Mat'l. Report 19

St. \_\_\_\_\_  
 Ave. No. 80  
Bay  
 Name of Owner \_\_\_\_\_  
Camberland Farms Tap is on  
Bay st.

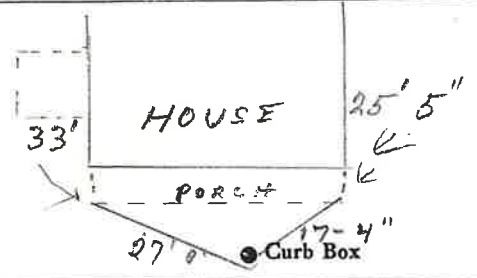
10" Main                      Elev. of Main at tap 5'  
 Gate at ●    ● Gate at

● Curb Box  
New Tap card, Tap is  
from old house Tap,
