St. Pl. Ave. No. 97
Bay
 Name of Owner

Labor and Mat'l. Report 19

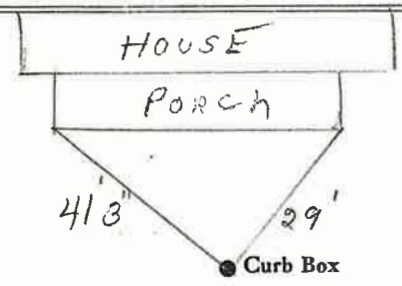
12 Main Elev. of Main at tap 5'

• Curb Box

"On" is "off" for curb box

SEWER GOES TO FULTON
