St. Pl. Ave. No. 159

Name of Owner
TAX ID # #302.16-7-7

Labor and Mat'l. Report 19

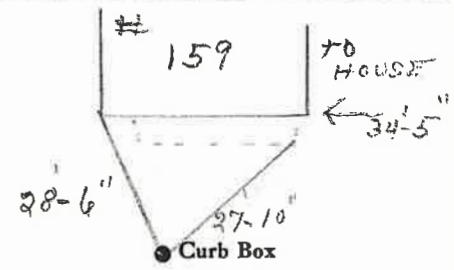
6" Main Elev. of Main at tap 6'

23' to MAIN

• Curb Box
