E BOYLSTON St. Ave. No. 32  
 Name of Owner  
 TAX ID # 309.16-8-20.2

Labor and Mat'l. Report for 2006

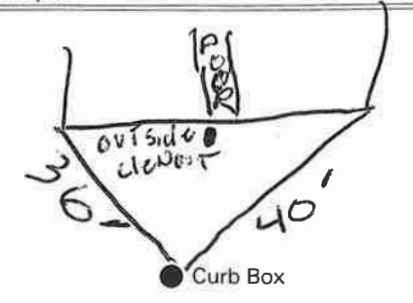
6" Main Elev. of Main at tap 4"  
 Gate at ● Gate at ●

● Curb Box

has outside clean under porch
