# LABOR AND MATERIALS

40 E. BOYLSTON <sup>St.</sup> <sub>40</sub>  
 Ave. No. 40

Labor and Mat'l. Report ~~to~~ **JUNE 27, 2001**

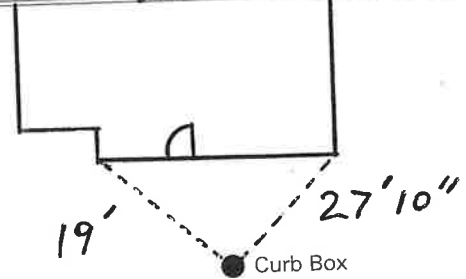
6" <sup>KH</sup> Main 6-27-2001 Elev. of Main at tap \_\_\_\_\_  
 Gate at ● Gate at ●

● Curb Box
