Coolidge St. Ave. No. 37

Name of Owner
Graham E. Asson

Labor and Mat'l. Report July 1 1976

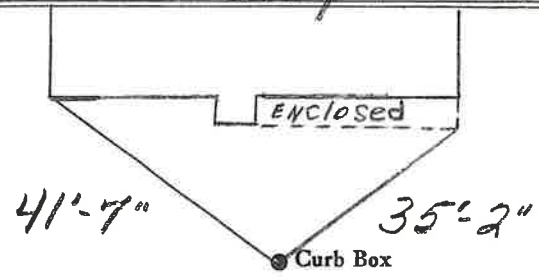
6" Main Elev. of Main at tap 5'

Gate at • Gate at
12' to MAIN

1" COPPER • Curb Box

1	Copper Lead	Connection	3/4"	\$
1	Curb	Cock Valve T.S. & V.	1 in. Orises #1	\$
1	Service box Old returned	{ Short 3 1/2 x 4 1/2 Long 4 1/2 x 5 1/2 Buff or Rdway		\$
12	Ft. 1 in.	{ Copper G.I. C.I.	Pipe at	\$
	Nipples	in. at		\$
	Bushings	to in. at		\$
	Red'g Inc'g	Coupl'gs to in. at		\$
	Union	in. at		\$
	Meter	in. at		\$
1	Lead Joints at	1" BYPASS ELBOW		\$
	Compound Joints at			\$
	Maintenance Foreman			\$
	Hrs. Water Maint. Man-1 at			\$
	Hrs. Water Maint. Man-2 at			\$
	Hrs. Garage Foreman at			\$
	Hrs. Labor— at			\$
	Hrs. Compressor at			\$
	Compensation Ins. at \$	per C		\$
	Trucking			\$
	Pav't Patch			\$
	Tap By Purvis & Co			\$
	July-1-1976			\$
	O'head			\$
				\$
