63-54

St. Cooper Ave. No. 114

Labor and Mat'l. Report Sept. 9 19 54

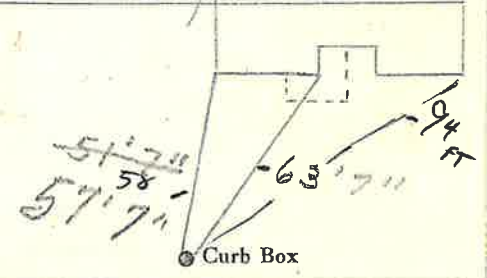
6" Main Elev. of Main at tap 4 1/2'

Gate at • • Gate at

• Curb Box
