St.   
 Pl.   
 Ave. No. 121

Name of Owner Hinstrank

Labor and Mat'l. Report June 1 1949

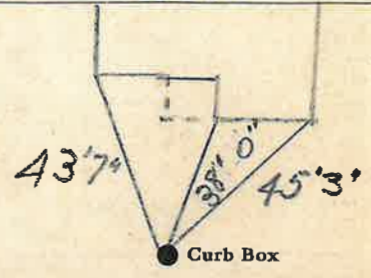
6" Main

Elev. of Main at tap 5'

● Curb Box
