Labor and Material Report Aug 11

no 39 Elm St

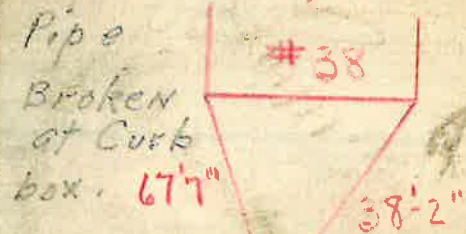
This
Curb box IN DRIVE way
of Parking lot
Main Elev. of Main at tap 5'

Copper connection shut off
at main. 11/22/50 because

Pipe
Broken
at Curb
box. 67 7/8"

● Connection for #39
