LABOR AND MATERIALS

Flandreau St. Pl. Ave. No. *20*

Name of Owner
Richard J. Conter

Labor and Mat'l. Report *April 22* 19*68*

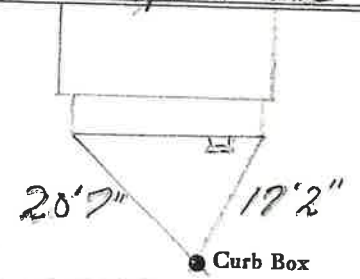
4" Main Elev. of Main at tap *4*'
Gate at • Gate at

• Curb Box

*Old Galv Water Service
3/4" Remove from main by
Gifford. April 22 68*
