Str. Flandreaux Ave. No. 14

Name of Owner Furlong

Labor and Mat'l. Report Sept 19 19 52

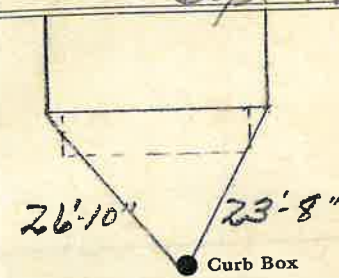
4" Main Elev. of Main at tap 4'

● Curb Box
