St. Ave. No. 3

Name of Owner
 MRS. Roberts Roberts

Labor and Mat'l. Report Aug 3 1973

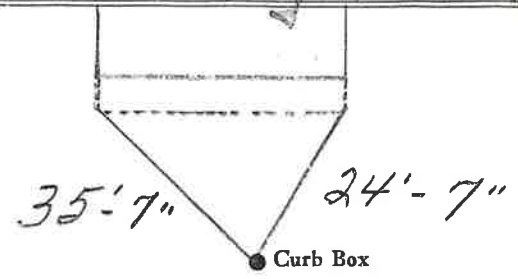
6" Main Elev. of Main at tap 5'
 Gate at • Gate at •

• Curb Box
