22 Astington

Labor and Mat'l. Report

Oct 1987

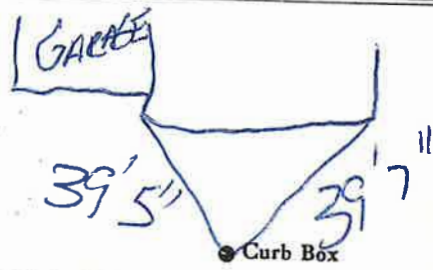
8" Main

Gate at ●

● Gate at

● Curb Box
