St. Pl. Ave. No. 44
BALDWIN
 Name of Owner
 TAX ID # 302.12-13-53

Labor and Mat'l. Report 19 81

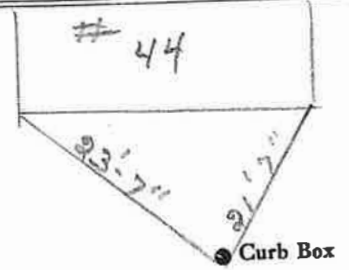
6' Main Elev. of Main at tap 5
 Gate at ● ● Gate at

● Curb Box

1	Copper Lead	Connection	$\frac{3}{4}$	\$
1	Curb	Cock Valve T.S. & V.	$\frac{3}{4}$ in.	\$
1	Service box Old returned	Short $3\frac{1}{2} \times 4\frac{1}{2}$ Long $4\frac{1}{2} \times 5\frac{1}{2}$ Buff or Rdway		\$
9	Ft.	Copper C.I. C.I.	$\frac{3}{4}$ in. Pipe at	\$
	Nipples	in. at		\$
	Bushings	to in. at		\$
	Red'g Inc'g	Coupl'gs to in. at		\$
	Union	in. at		\$
	Meter	in. at		\$
	Lead Joints	at		\$
	Compound Joints	at		\$
	Maintenance Foreman			\$
	Hrs. Water Maint. Man	1 at		\$
	Hrs. Water Maint. Man	2 at		\$
	Hrs. Garage Foreman	at		\$
	Hrs. Labor	at		\$
	Hrs. Compressor	at		\$
	Compensation Ins.	at \$ per C		\$
	Trucking			\$
	Pav't Patch			\$
				\$
				\$
				\$
	O'head			\$
				\$
