St.
Pl.
Ave. No. 48

BALDWIN

Labor and Mat'l. Report

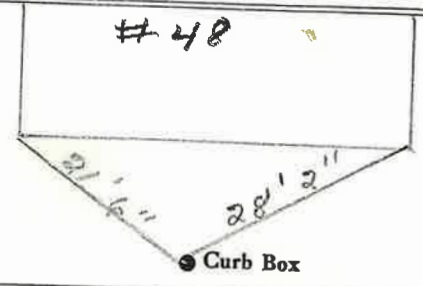
6 Main

Elev. of
Main at tap 6

Gate at ●

● Gate at

● Curb Box
