Baldwin St. ~~Pl.~~
Ave. No. 52

Name of Owner
TAX ID # 302.12-13-57

Labor and Mat'l. Report 19 81

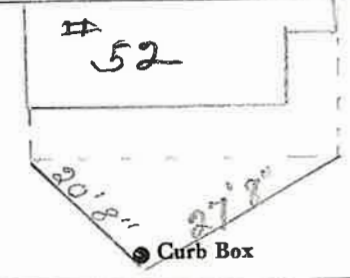
6" Main Elev. of Main at tap 5
Gate at • Gate at •

• Curb Box
