St. _____
 Pl. _____
 Ave. No. 89

Name of Owner Bentley

Labor and Mat'l. Report Nov. 23 19 70

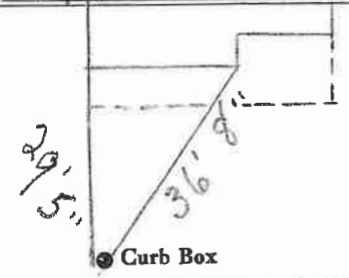
10" Main Elev. of Main at tap 5 1/2'

Gate at • Gate at

• Curb Box
