St. PL
Ave. No. 119

TAX ID # 302.16-17-29

Labor and Mat'l. Report

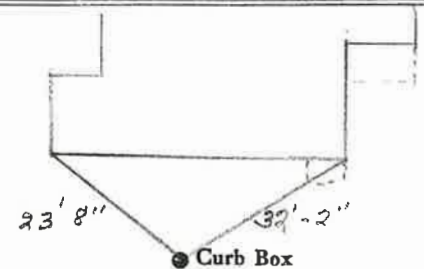
6 Main

Elev. of Main at tap 5 1/2

Gate at ●

● Gate at

● Curb Box
