St. PL  
PL  
 Ave. No 128  
 Name of Owner BAY  
 TAX ID # 302.16-12-8

Labor and Mat'l. Report 19

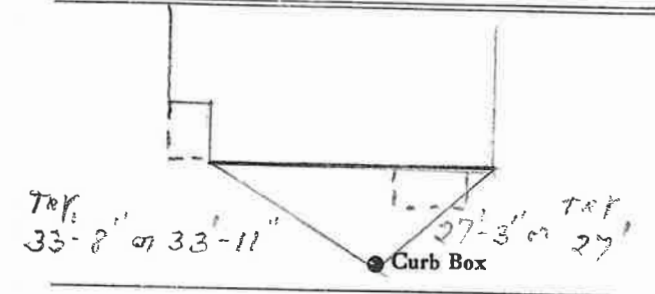
6 Main Elev. of Main at tap 5 1/2  
 Gate at ● ● Gate at

● Curb Box
