*E. Beacon*

St. *M.*  
Ave. No. *12*

*Harold Suckman*

Labor and Mat'l. Report

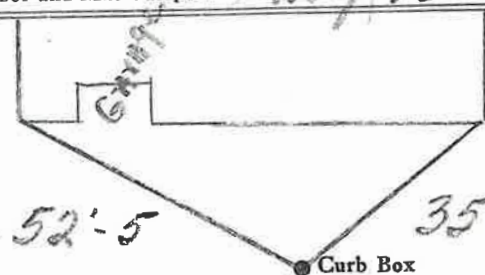
*6"* Main

Elev. of Main at tap *6'*
