St.
 Pl.
 Ave. No. 4

Labor and Mat'l. Report AUG 23 1939 19

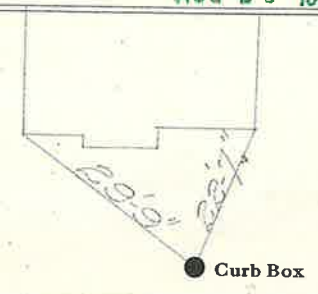
6" Main Elev. of Main at tap 51

Gate at ● Gate at ●

● Curb Box

1-3/4" Cop. to Cop Coupling
 3-3/4" K. Copper used
 To repair leak 9-24-54

Leak Developed AND
 Was Dog up ground
 Copper Pipe.
 Repaired - 9-24-54.
