BROAD St. Ave. No. 10
 Name of Owner
 RITE AID

Labor and Mat'l. Report 1993

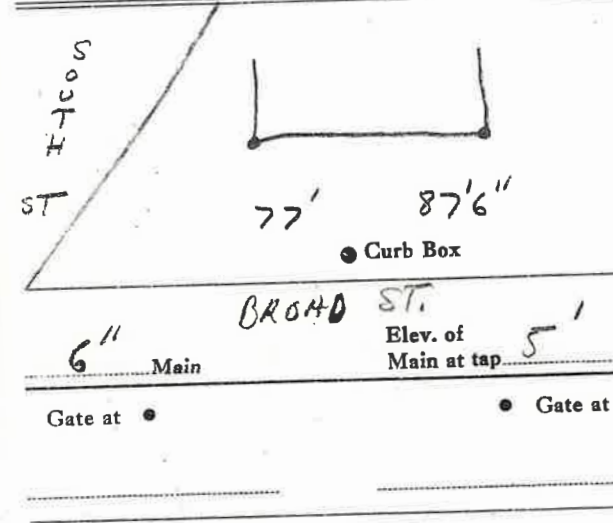
6" Main
 Gate at •
 Elev. of Main at tap 5'
 Gate at •

• Curb Box
