BROAD St. _____
 Pt. _____
 Ave. No. *142*

5/14/07
 Labor and Mat'l. Report ~~JULY 19~~

5/14/07 ● Curb Box
NEW TAP AND SERVICE

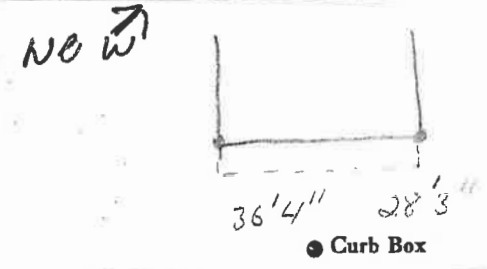
6" Main Elev. of Main at tap *6'*
 Gate at ● Gate at

old OFF AT MAIN 5/14/07
