LABOR AND MATERIALS

St. Pt. Ave. No. 6

Name of Owner
Saint Alphonsus Church

Labor and Mat'l. Report Aug 31 1965

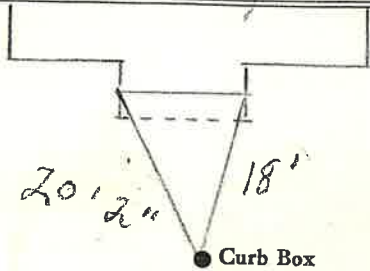
8" Main Elev. of Main at tap 5'

Gate at • • Gate at

• Curb Box
