LABOR AND MATERIALS

DIX 56
22
Ave. No. 26

Labor and Mat'l. Report JUNE 16 1933

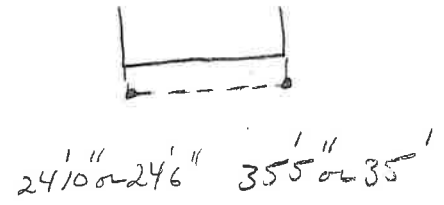
6" Main Elev. of
Main at tap 5'

OLD TAP SHUT OFF
