St. ELIZABETH No. 20

Labor and Mat'l. Report AUG. 1 1929

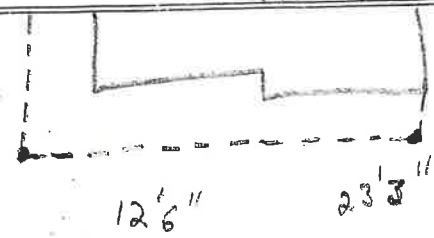
6" Main Elev. of Main at tap 4 1/2'

OLD TAP SHUT OFF
AT MAIN
