St.  
"Pl."  
Ave. No. *59*

Labor and Mat'l. Report

*Aug 21* 1948

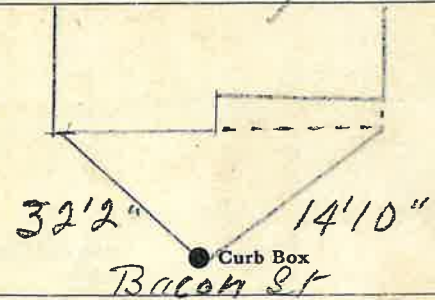
6" Main

5'

*This Tap on Bacon St.*
