St. FIRST
 Ass. No. 64

Name of Owner
 TAX ID # 309.11-7-14

Labor and Mat'l. Report MAY 7, 1929

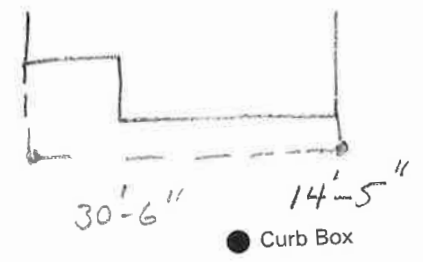
6" Main

Elev. of Main at tap 4 1/2'

● Curb Box

OLD LEAD SHUT OFF
