Ft. Amberst St. Pl. Ave. No. 28

Name of Owner  
 Constantine Backus

Labor and Mat'l. Report May 9 1963

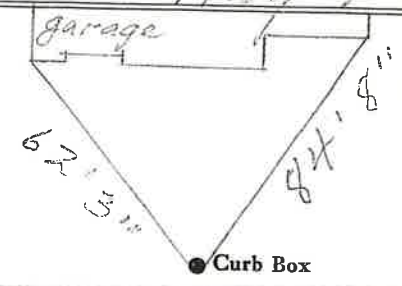
6" C.I. Main Elev. of Main at tap 5'

• Curb Box
