GARFIELD St **59**
 Pl. No. _____
 Ave. No. _____
 Name of Owner _____

MEASURED
 Labor and Mat'l. Report ~~XX~~ **JUNE 12, 2002**

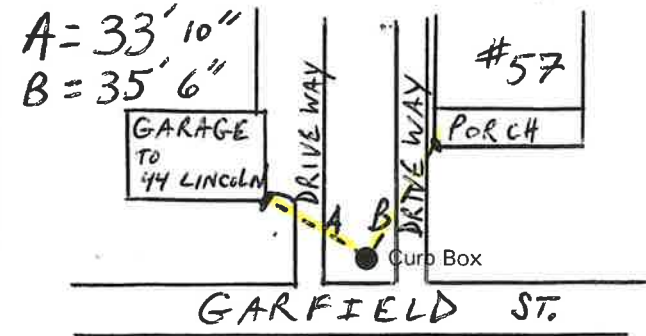
Main _____ Elev. of Main at tap _____
 Gate at ● _____ Gate at ● _____
 — NO LONGER IN SERVICE —
 ● Curb Box

THIS CURB BOX IS NOT
 IN SERVICE. CURB BOX
 FOR LOT #59 WAS
 DISCONNECTED FROM MAIN
 JUNE 12TH 2002. BY T. MISSITA
