St.
 Pl.
 Ave. No. 25

Regan

Labor and Mat'l. Report Nov 14 1945

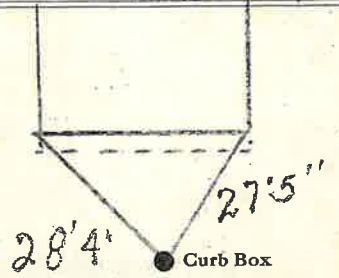
4 Main

Elev. of Main at tap 5

Gate at ●

● Gate at

● Curb Box

- REPAIRED LEAK 10-12-00
