Glen St. Ave. No. 559
 Name of Owner _____

Labor and Mat'l. Report 19 26, June 30

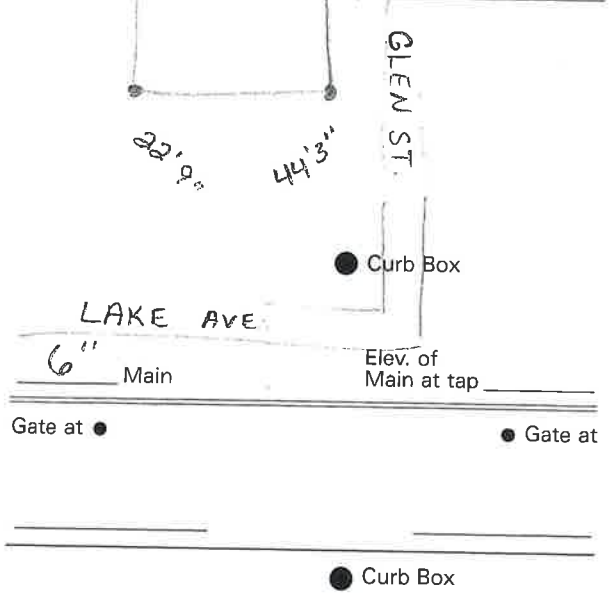
measurements from Lake Ave.,
 Tap on lake Ave, old, to be dug
 up of Glen St.
