LABOR AND MATERIALS

GRANT St. Ave. No. 76

Labor and Mat'l. Report Oct. 4 1972

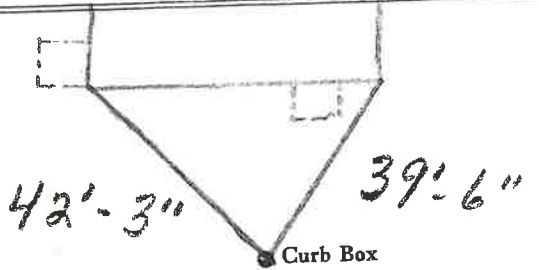
6" Main Elev. of Main at tap $5 \frac{1}{2}'$

• Curb Box

1 Copper Connection $3/4"$ \$
~~Lead~~ }
 1 Curb Cock Valve } $5/4$ in. MARK II OR \$ SEAL
 1 Service box { Short $3/2 \times 4/2$ } $4' \times 5'$
 Old returned { Long $4/2 \times 5/2$ }
 { Buff or Rdway }
 11 Ft. $3/4$ in. { Copper } Pipe at \$
 { Gal. }
 Nipples in. at \$
 Bushings to in. at \$
 Red'g } Coupl'gs to in. at \$
 Inc'g }
 Union in. at \$
 Meter in. at \$
 Lead Joints at \$
 Compound Joints at \$
 Maintenance Foreman \$
 Hrs. Water Maint. Man-1 at \$
 Hrs. Water Maint. Man-2 at \$
 Hrs. Garage Foreman at \$
 Hrs. Labor at \$
 Hrs. Compressor at \$
 Compensation Ins. at \$ per C \$
 Trucking \$
 Pav't Patch \$
 Tape made by \$
 St. John \$
 O'head $Oct-4-1972$ \$
