# LABOR AND MATERIALS

GRANT St. Ave. No. 79  
 Name of Owner \_\_\_\_\_

Labor and Mat'l. Report 19 32, MAR. 14

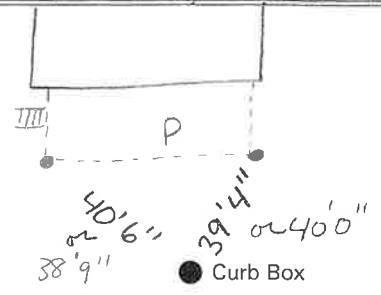
6" Main Elev. of Main at tap 5'

Gate at ● Gate at ●  
 ● Curb Box
