# LABOR AND MATERIALS

GROVE

Ave. No. 26

Labor and Mat'l. Report 1930, NOV. 12

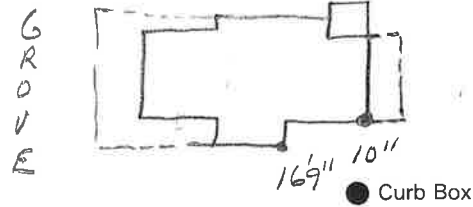
6" Main

Elev. of Main at tap 5'

● Curb Box

OLD TAP DISCONNECTED
