St. 7
 Pl. 7
 Ave. No. 7

Harlem

Labor and Mat'l. Report Aug. 21 19 39

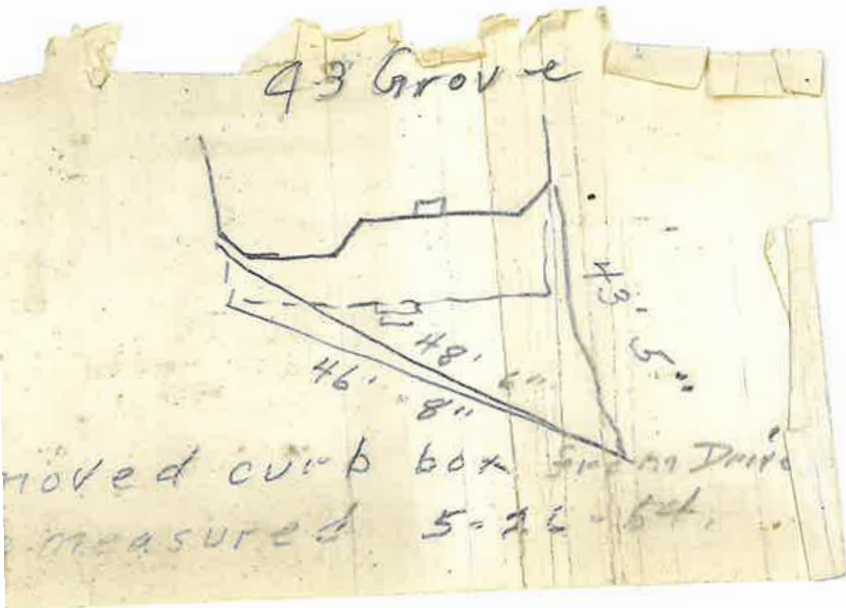
2 Curb boxes

30'

North of

Buffalo

88'

Hydt. corner Harlem + Washington Str.

Now being
Used by
Glens Falls Ins,
Co.
Parking lot
Hyatt

This curb box removed 11-5-70 By Peck & Dunyer.

Moved curb box from a driveway
Re measured 5-26-64
