St. _____
Pl. _____
Ave. No. 28

Name of Owner
O'Connor

Labor and Mat'l. Report Oct 10 1938

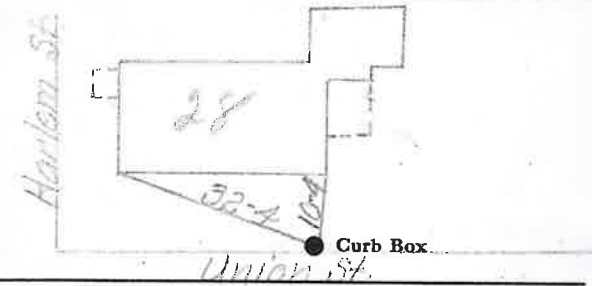
4" Gal. Main
Elev. of Main at tap _____
Gate at ● Gate at ●

● Curb Box

Renewal
Made by Penor.
