57¹⁰
 Labor and Material Report *401* 16, 19³⁶

39 Haskell Ave

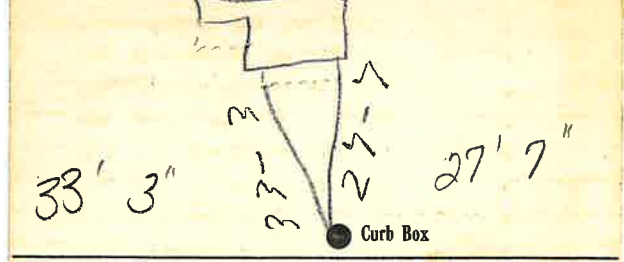
6 Main Elev. of Main at tap $4\frac{1}{2}$

● Curb Box

*old lay slat of at
 frame*
