# LABOR AND MATERIALS

Name of Owner  
Matt Ball

Labor and Mat'l. Report 12/7/11  
Tap is on Basin St.

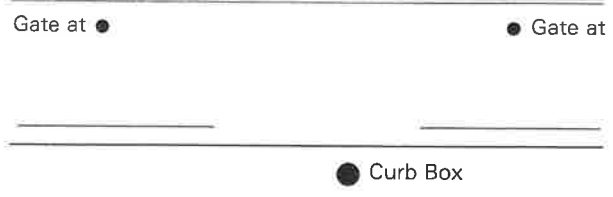
6" Main Elev. of Main at tap 8'
