**LABOR AND MATERIALS**

HORICON

St. ~~Pl~~ Ave. No. 24

TG III - MEASUREMENTS RECORDED  
 Labor and Mat'l. Report 19 09-05-2002

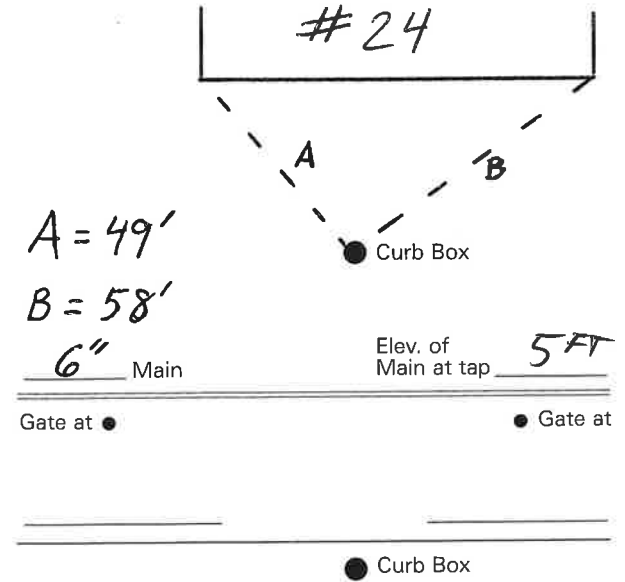
**20FT. TO THE MAIN LINE**  
**3/4" COPPER**  
**4FT. DEEP**  
**16" WATER MAIN**
